General Summary

Client Name: Justin A Smith Property Address: 1234 The Town Circle
(Street)

Client Name: Jane B Smith N. Charleston, SC, 29405
(City, State, Zip Code)

Inspector Name: Justin Oliver LIC#: 49689

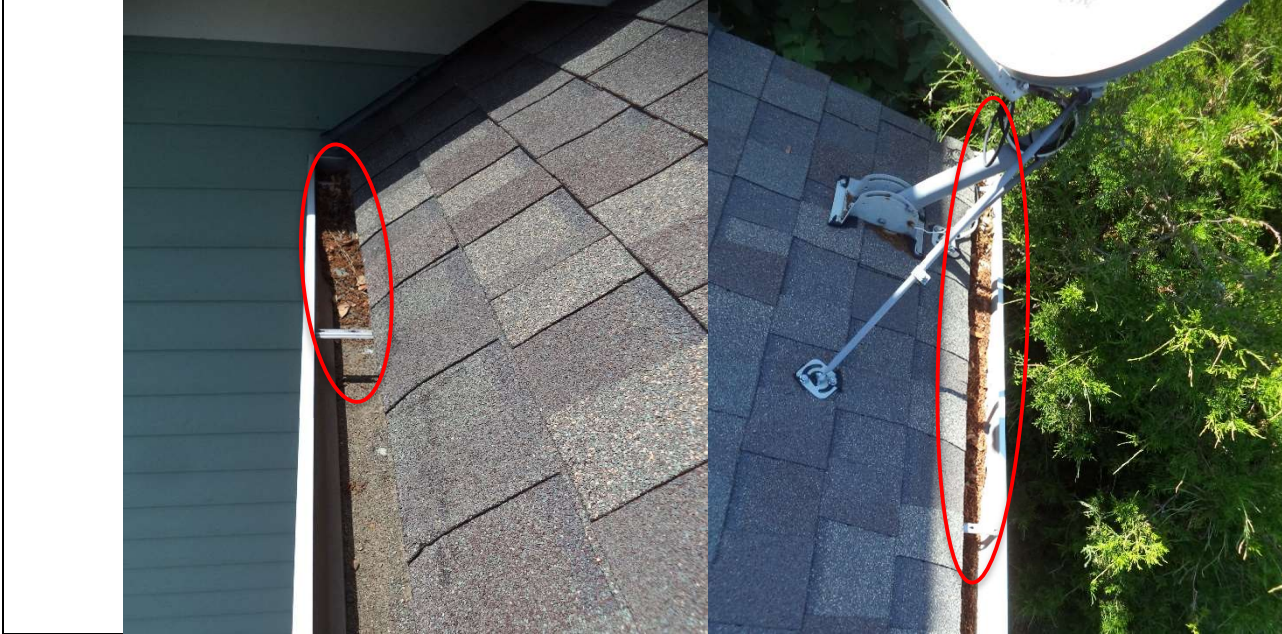
Gutters should be cleaned to prevent backflow onto roof and under shingles to protect roof sheathing edge.

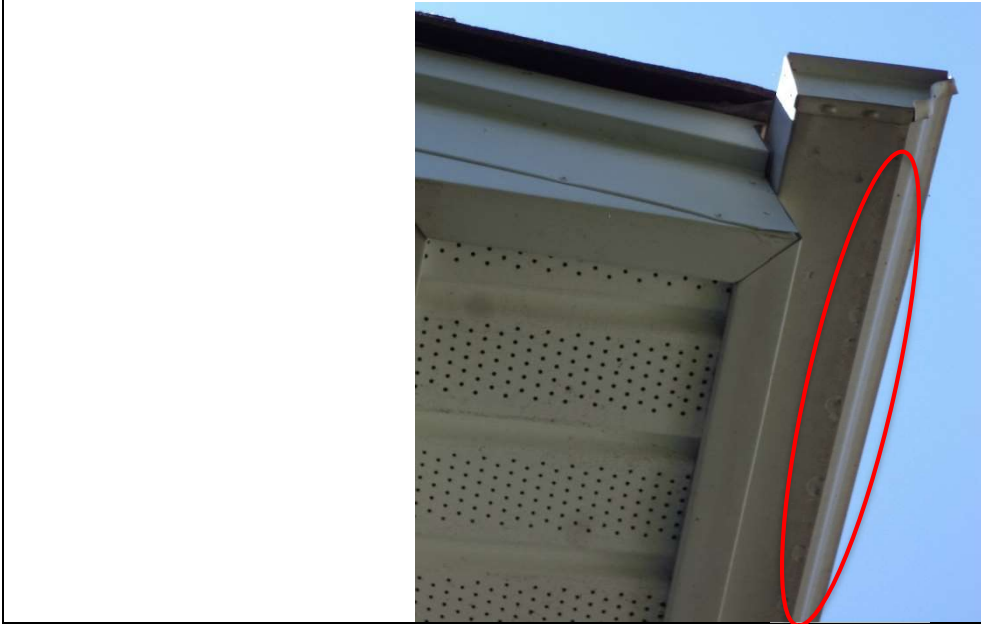
Porch Roof North (Rear) Gutter over screen door may show signs of loose/uncaulked end cap. Recommend consulting with a qualified gutter installer

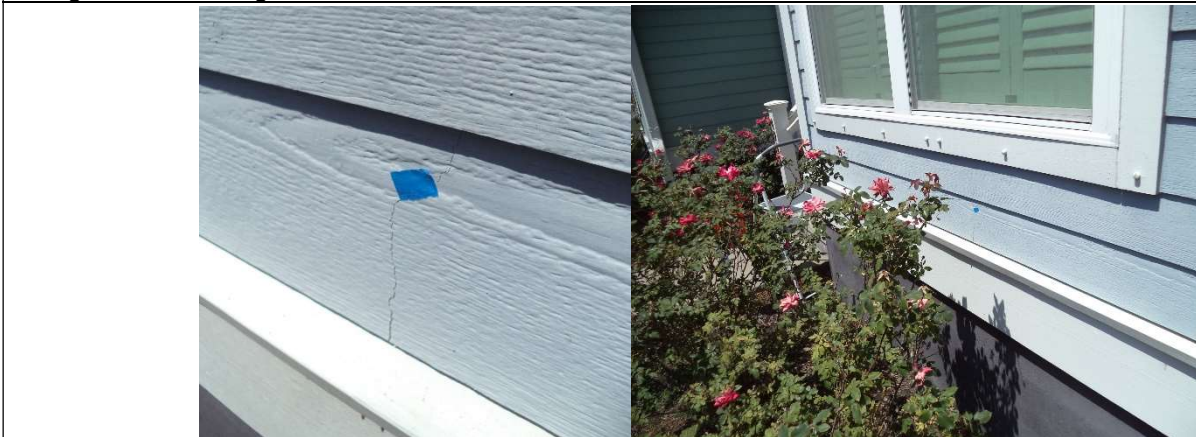
Front below dining room window

Two locations where siding was cracked | Suspected improper nailing technique | Caulking repair is recommended along with monitoring over time.

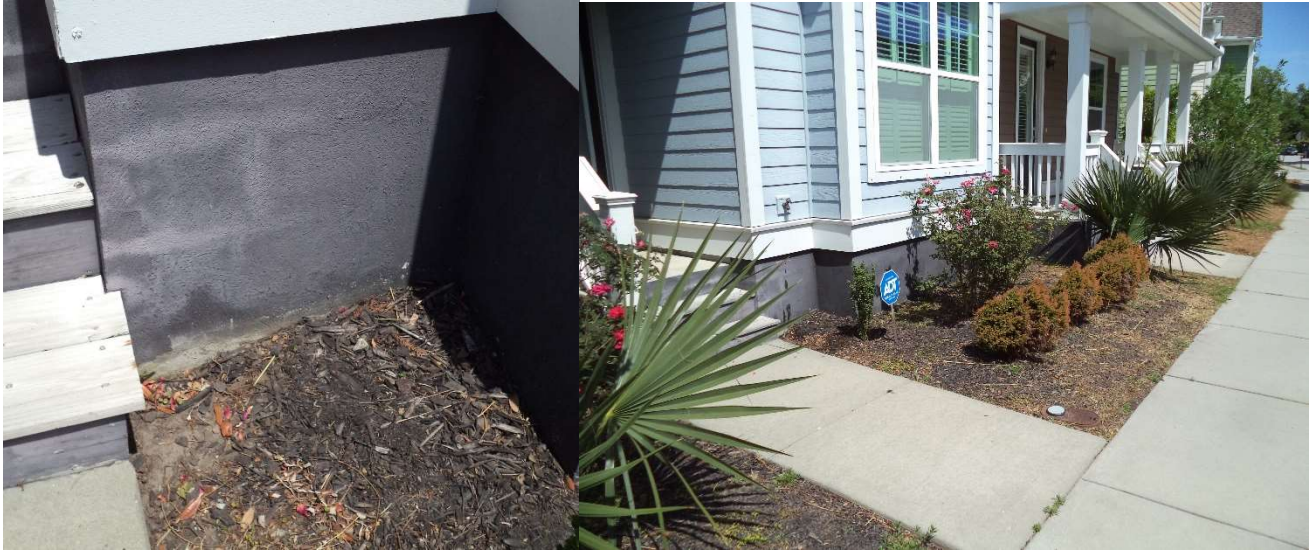
Front

Block wall appears to be in satisfactory condition but recommend resealing to protect and prevent moisture intrusion.

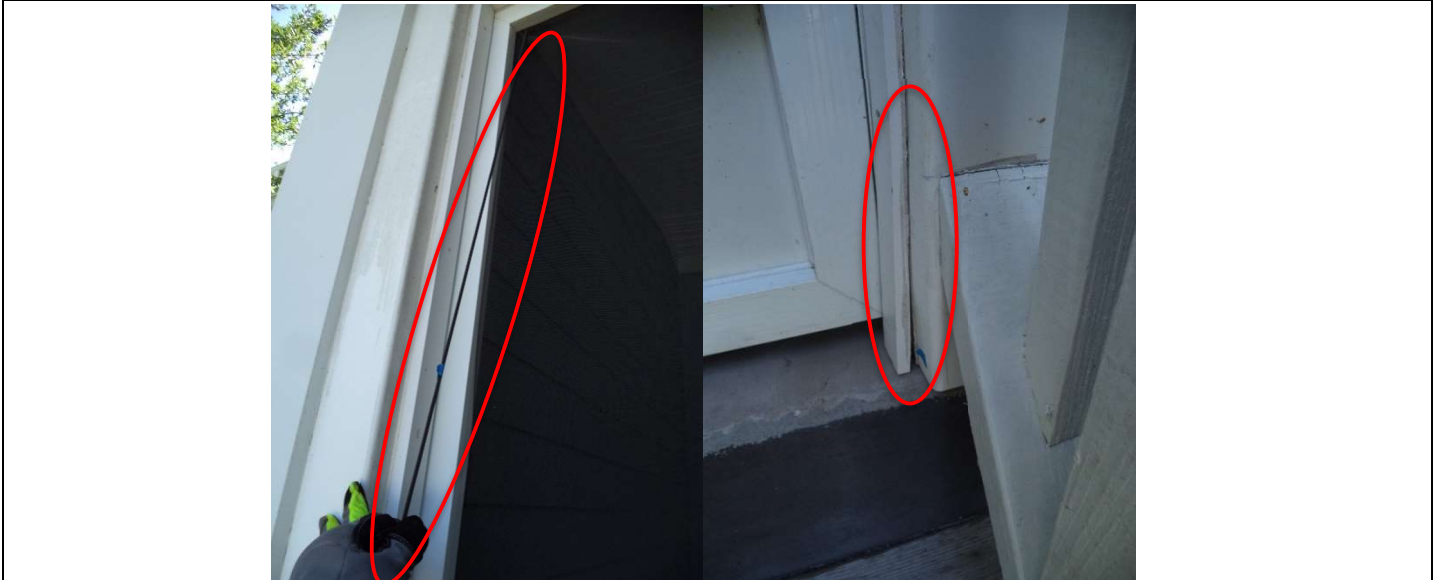
Rear porch screen door has broken upper screen | Pulled gasket | Damaged Trim

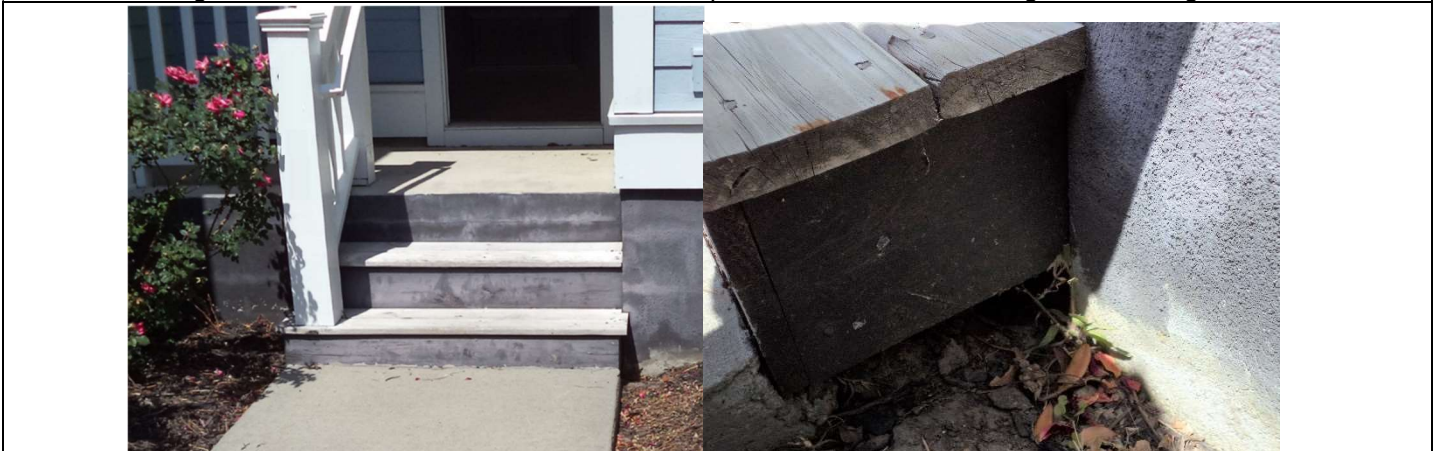
Wooden Stairs at both front and rear porches are in Marginal condition should be resealed and coated to protect from weathering. Holes near stairs should be addressed to prevent wildlife from nesting and intruding into home.

Front Stair | Hole below stairs should be filled to prevent water and wildlife

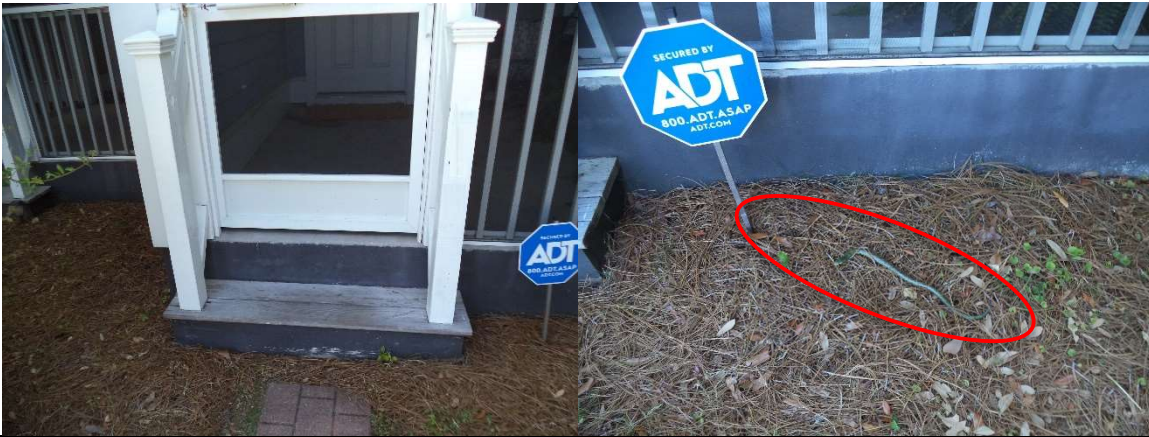
Rear Stair | Glass Snake was in straw heading to stairs

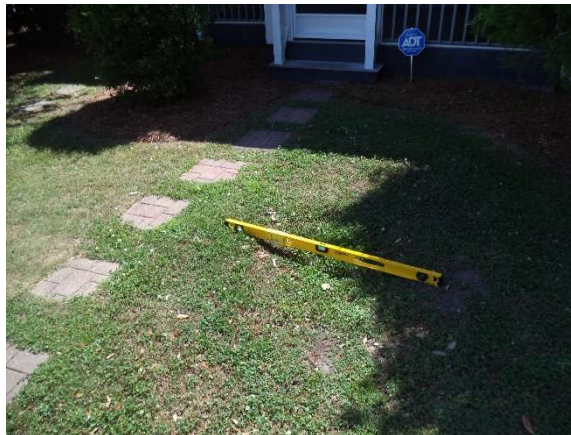
Rear Walk between gravel parking and porch stair has a depression which should be backfilled to prevent injury

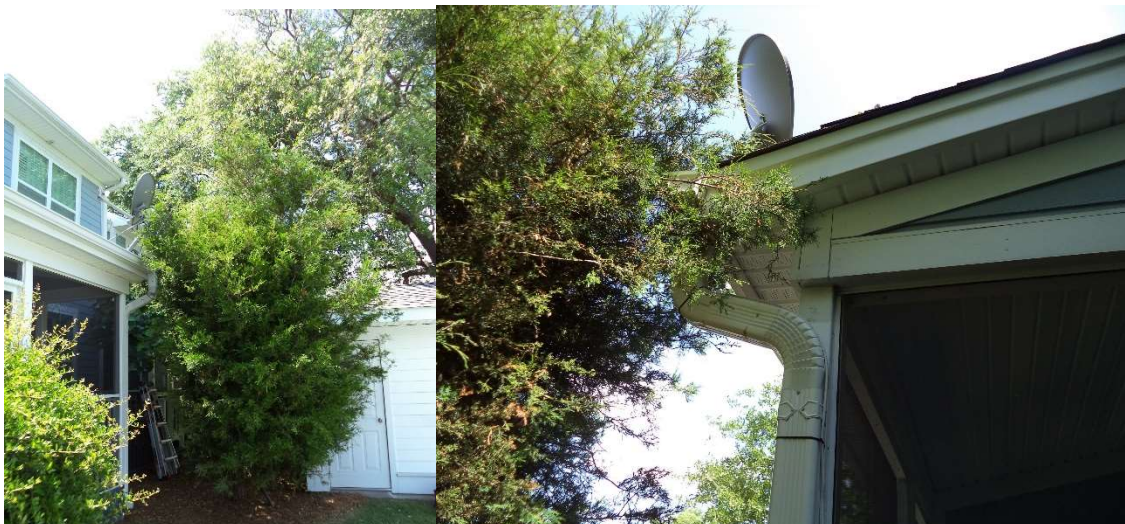
Rear – Tree should be pruned to prevent future damage to porch roof and screen

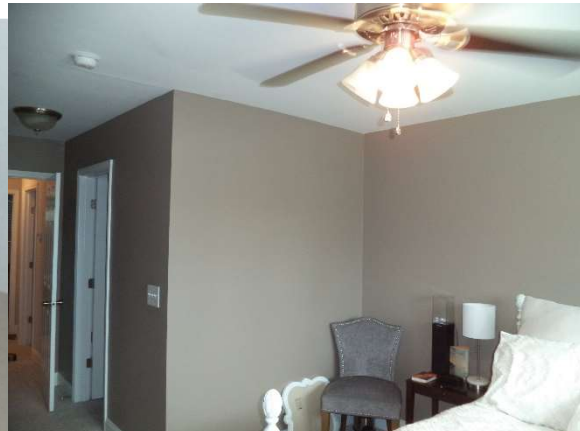
Ceilings throughout the house did not show indication of any active leaks. There was an observed joint cracking potentially due to normal thermal expansion of the home

Ceiling Joint in master bedroom shows some sign of cracking potentially from normal thermal expansion of the attic space | no active leak obvious in conjunction with joint | recommend minor maintenance and monitoring

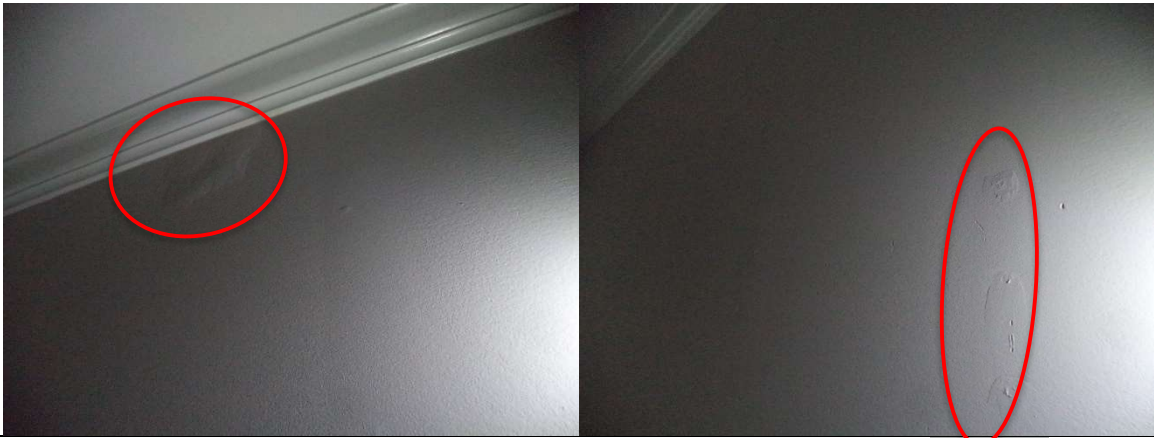
Living room - Indeterminate Patch | wall repair – nail/screw holes

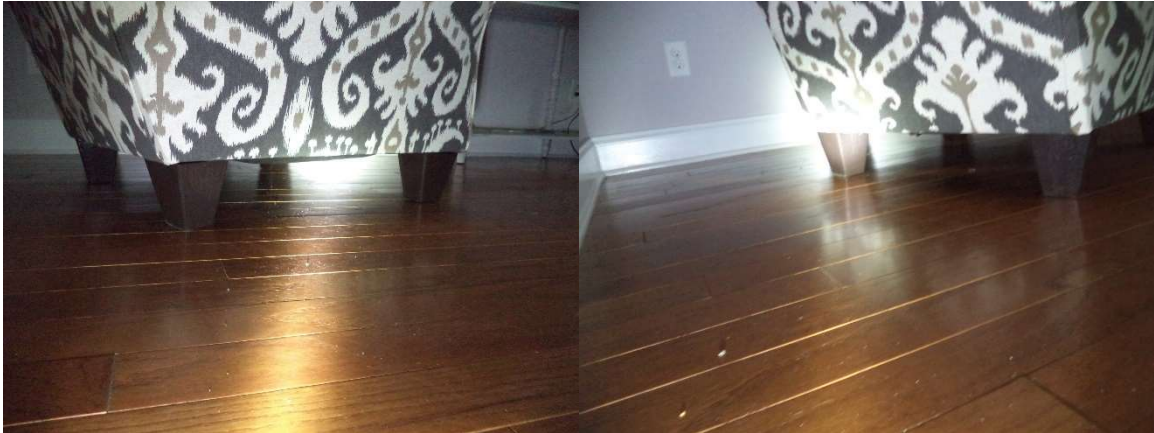
1st floor T-G Flooring appears to have local low spots which may be due to installation techniques, but may also indicate moisture (spill, pet stains, or moisture wicking) | The flooring did not move or squeak | Recommend monitoring

Living Room Flooring presumed to be installed over vapor barrier on top of concrete slab

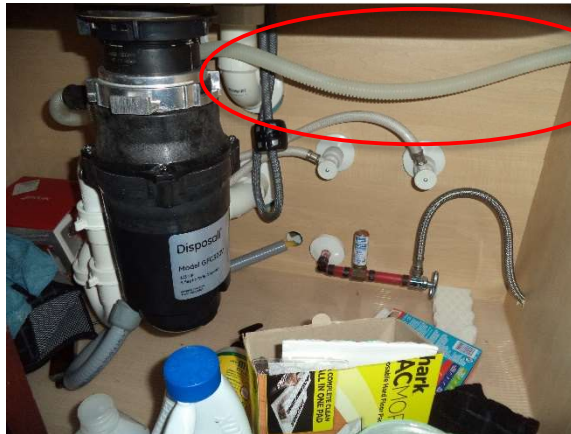
No Sanitary loop or air gap was noted | Recommend adding a loop under the sink to prevent backflow into dishwasher

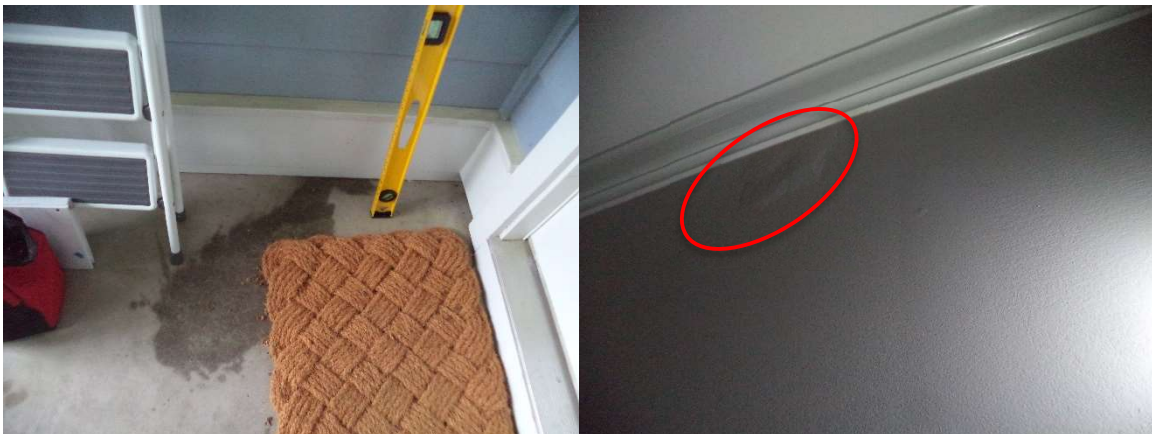
Potential past water issue in shared wall with East resident

Stain on Porch Concrete and Upper Drywall Repair

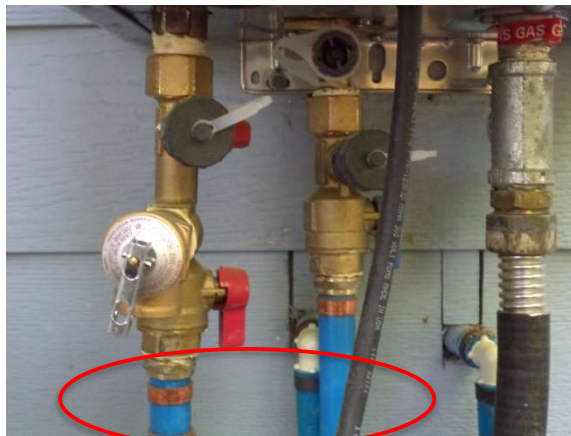
PEX tubing at the HW HTR – Insulation for exposed distribution piping is recommended to reduce freezing

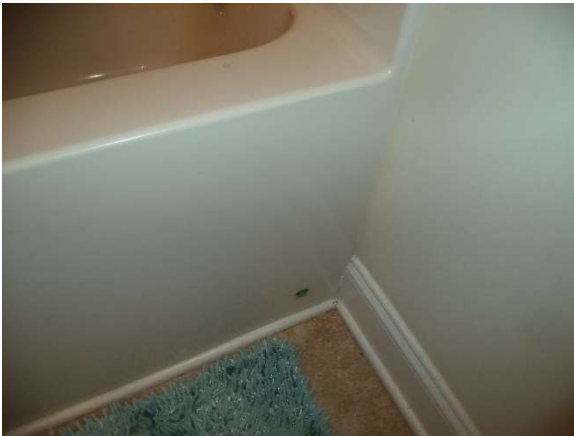
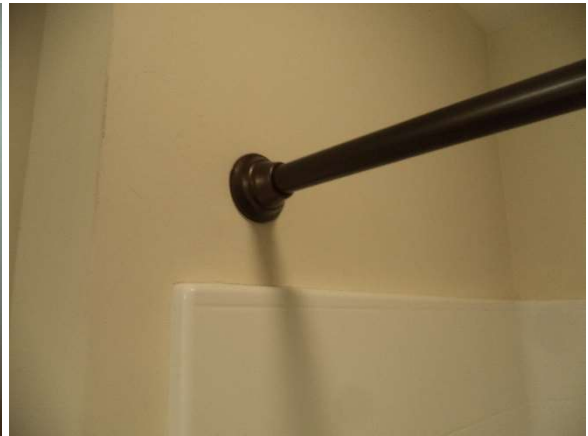
Diverter valve has a small leak when shower is activated | Temp from cold to warm was less than 30 seconds and hot within a minute | Tub drain held water without any obvious draining over several minutes | Drain was free flowing | Water flow was slightly diminished when flushing toilet.

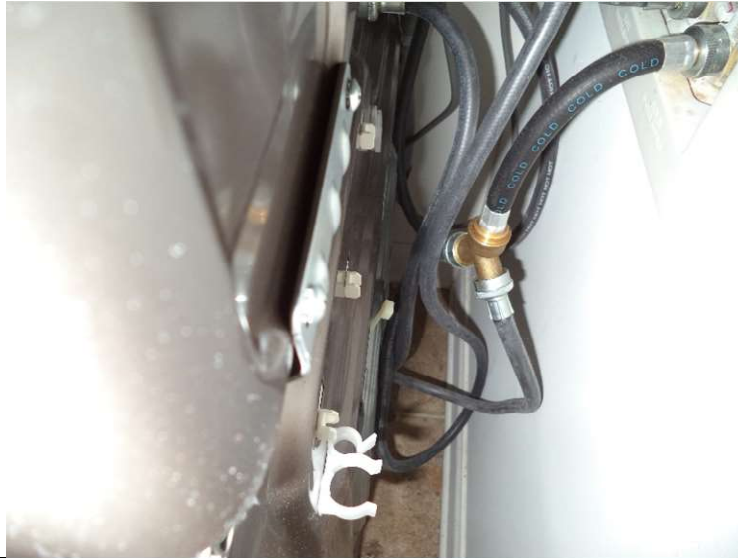
The existing washer connections were not visible behind the stacked washer/dryer unit, but were photographed by reaching to the rear of the machine. Recommend removing unit to check for any potential damage to hoses of fittings which are not evident in the below photo from the inspection. There is no evidence of water staining or leaking from the fittings, hoses or on the floor/wall to suggest the equipment is not functioning satisfactory at the time of inspection.

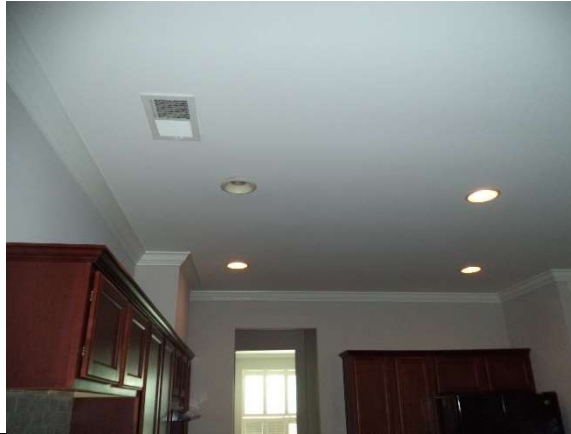
Recessed Lighting in the kitchen revealed on light was not functional (likely blown). The Lighting for the Kitchen appeared to be dimmer than what would be acceptable for normal kitchen activities. No Dimmer switch was located. This may be a wattage issue that should be addressed by changing to a higher watt bulb, or consulting a qualified electrician to modify the type of lighting available in the kitchen.

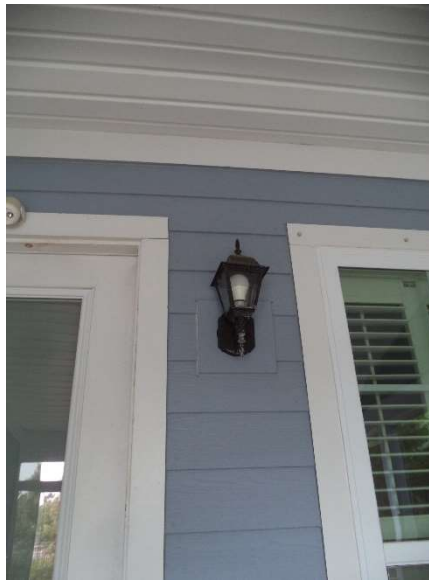
The lighting on the rear porch was tested from the wall switch bank adjacent to the rear entry and did not result in a functional porch light. Recommend replacing the light bulb and if results are unchanged consult a qualified electrician for troubleshooting or replacement of the fixture.

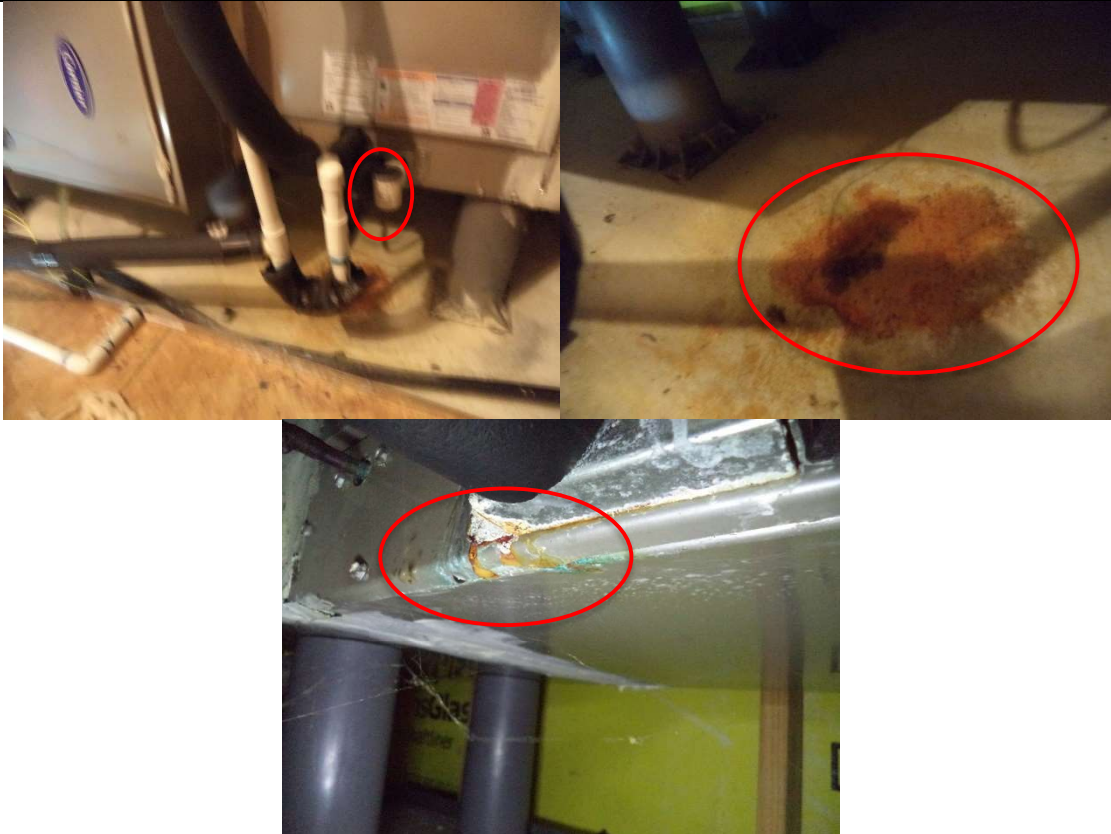
Active Leak from condensate line connection with air handler cabinet | Recommend consulting a qualified HVAC technician to perform routine maintenance and evaluate the connection repair as needed.
