General Summary

Client Name: Justin A Smith Property Address: 1234 The Town Circle
(Street)

Client Name: Jane B Smith N. Charleston, SC, 29405
(City, State, Zip Code)

Inspector Name: Justin Oliver LIC#: 49689

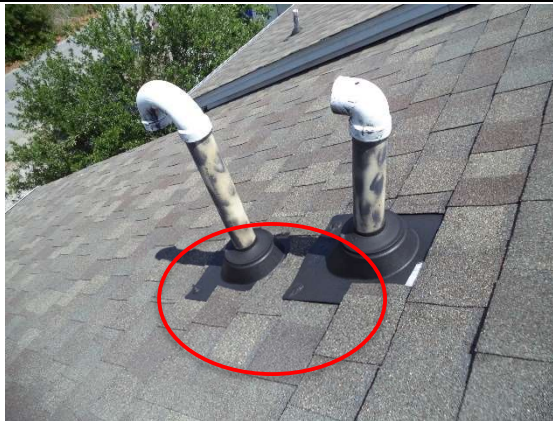
1.3 ROOF PENETRATIONS

Roof Penetration boots did not have consistent shingle coverage as others viewed and may require some caulk to prevent wicking or leaking. Monitor from attic over time or consult with a qualified roofing professional.

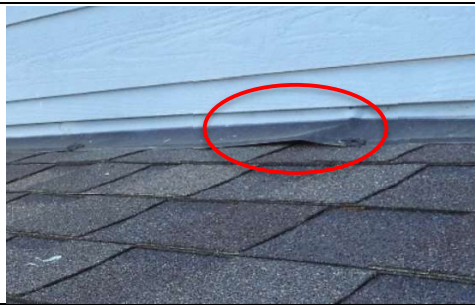
1.4 ROOF FLASHING

Flashing crimp at porch-wall attachment below window should be caulked to prevent moisture from wicking below siding or posing a potential leak with driven precipitation.

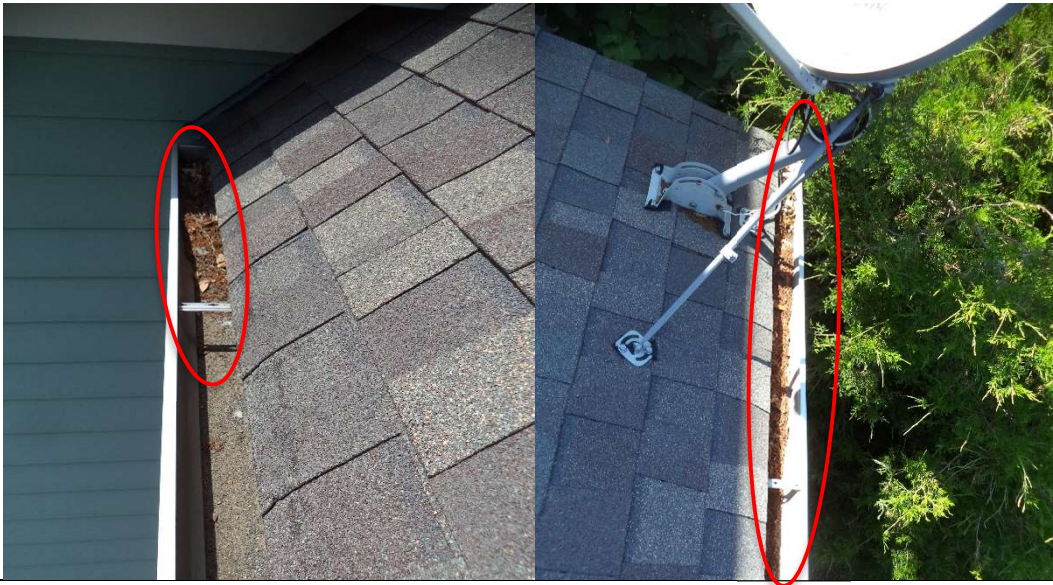
1.6 ROOFING DRAINAGE

Gutters should be cleaned to prevent backflow onto roof and under shingles to protect roof sheathing edge.

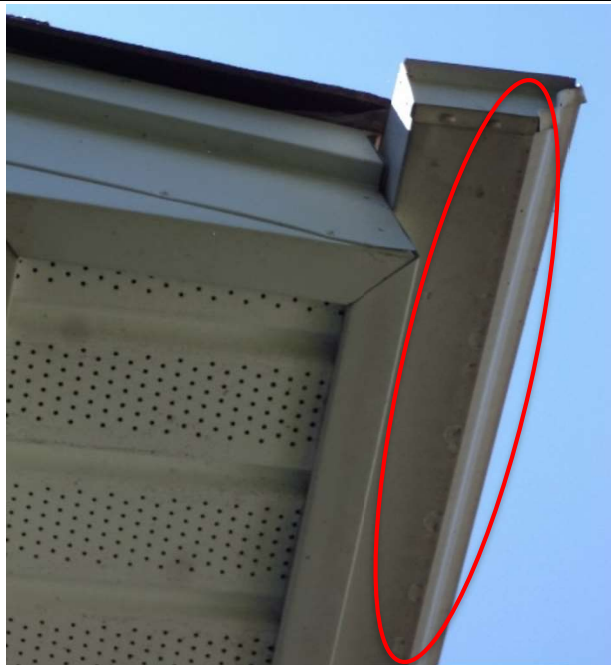
Porch Roof North (Rear) Gutter over screen door may show signs of loose/uncaulked end cap. Recommend consulting with a qualified gutter installer

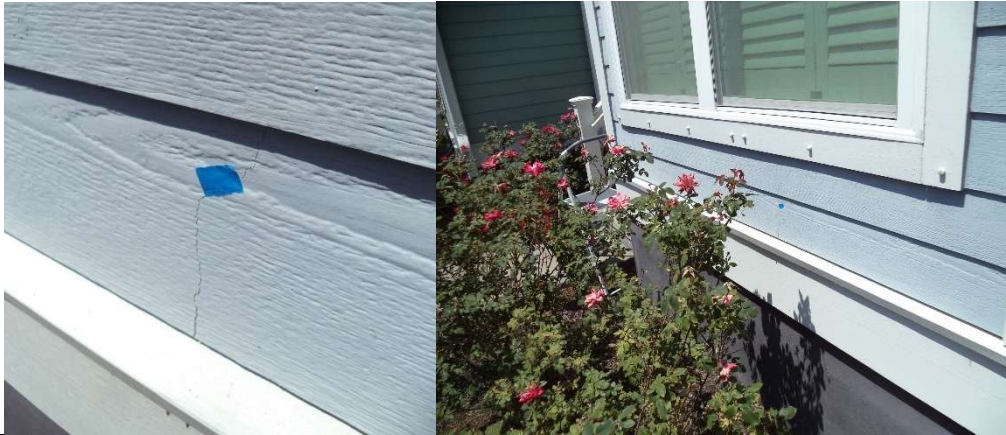
Front below dining room window

Two locations where siding was cracked | Suspected improper nailing technique | Caulking repair is recommended along with monitoring over time.

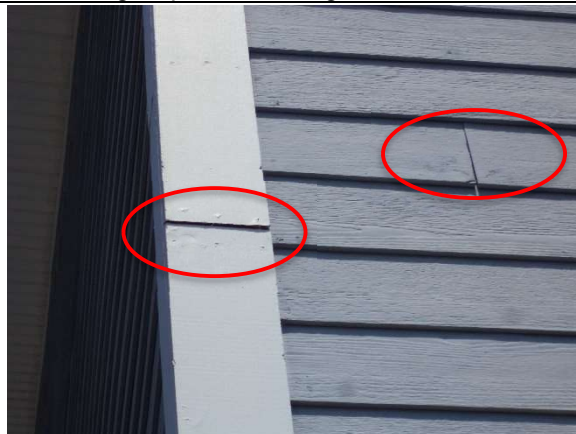
Front Upper Corner over Porch

Siding and Facia/Trim locations where siding requires caulking maintenance.

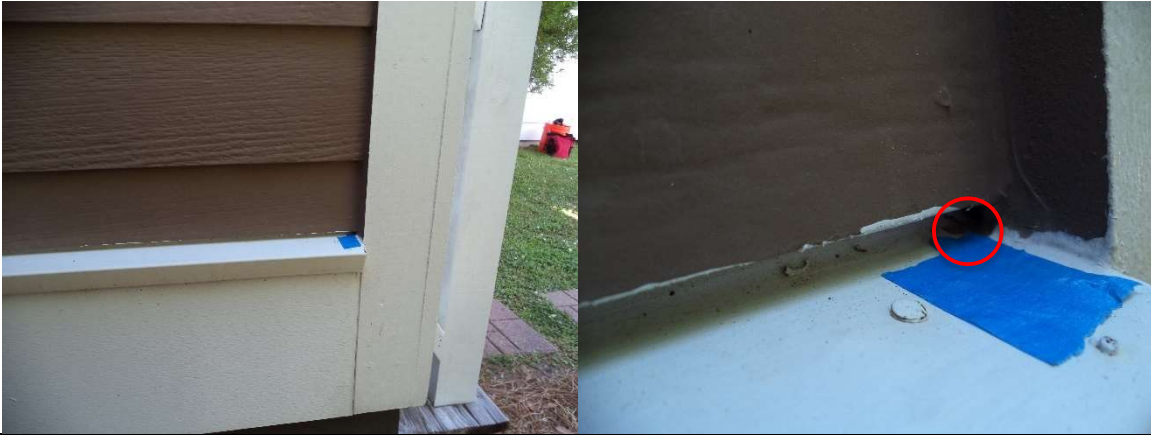
Rear Porch – Small hole for insects to penetrate to wood

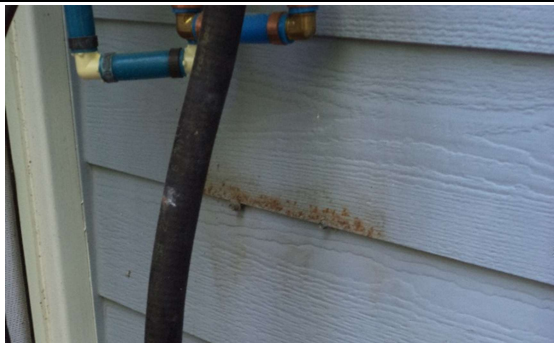
Rear

There is rust on the siding below the Rinnai HW HTR which is not an active leak, but appears to be where a bracket or equipment was removed.

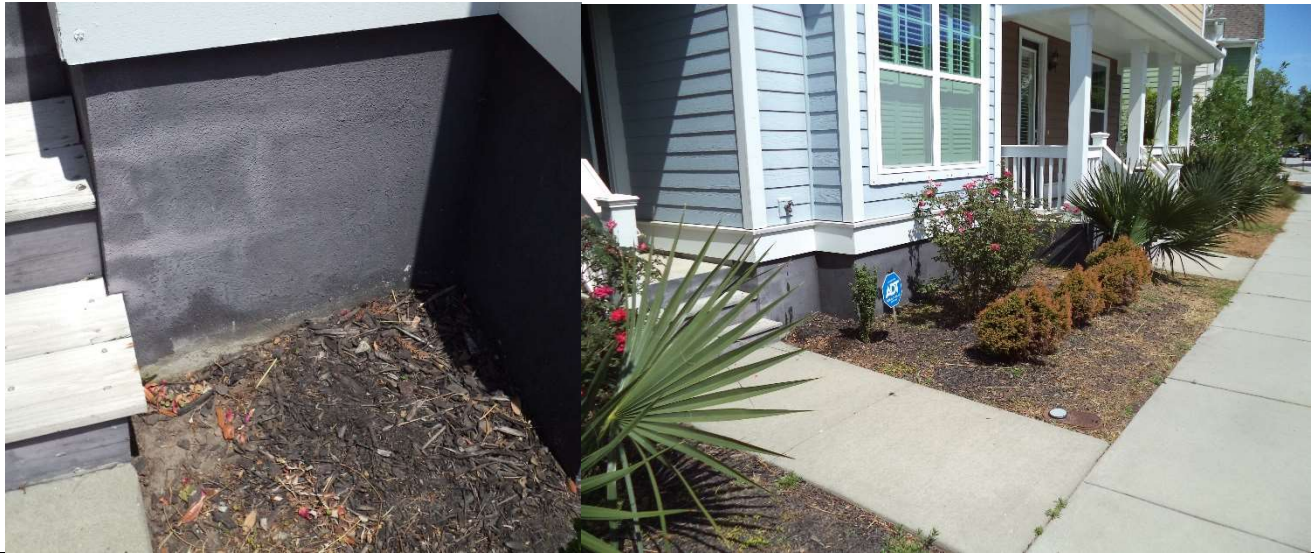
Front

Block wall appears to be in satisfactory condition but recommend resealing to protect and prevent moisture intrusion.

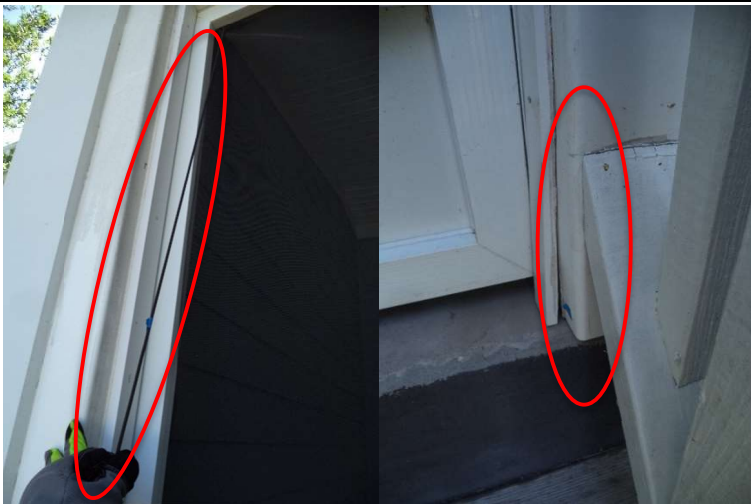
Rear – Screen Door

Rear porch screen door has broken upper screen | Pulled gasket | Damaged Trim

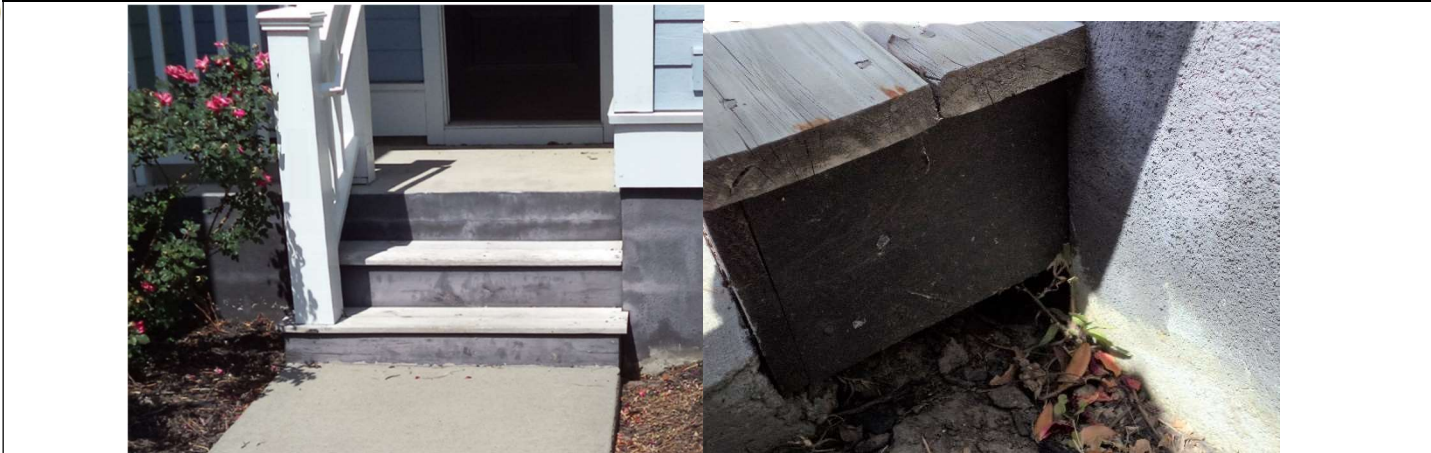
Wooden Stairs at both front and rear porches are in Marginal condition should be resealed and coated to protect from weathering. Holes near stairs should be addressed to prevent wildlife from nesting and intruding into home.

Front Stair | Hole below stairs should be filled to prevent water and wildlife

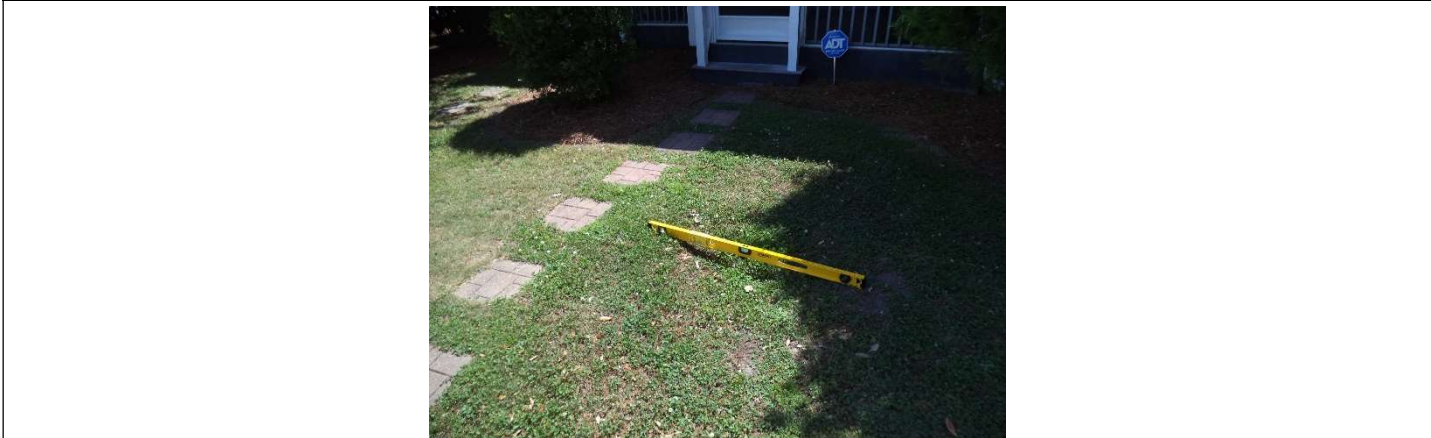
Rear Walk between gravel parking and porch stair has a depression which should be backfilled to prevent injury.

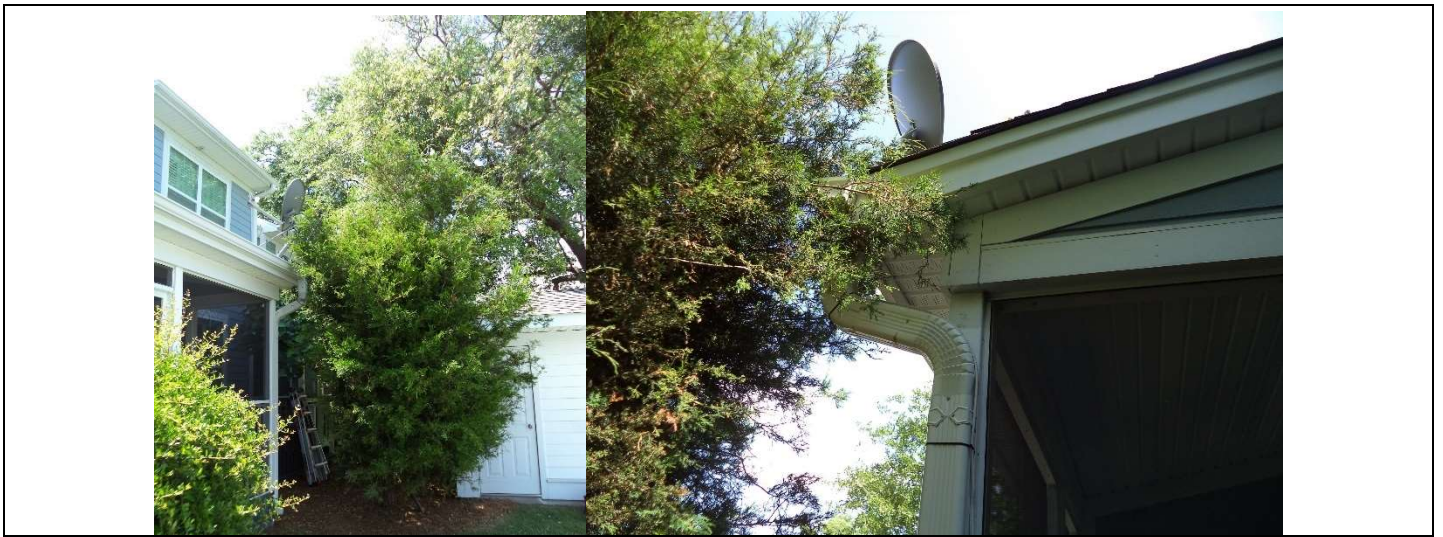
Rear – Tree should be pruned to prevent future damage to porch roof and screen

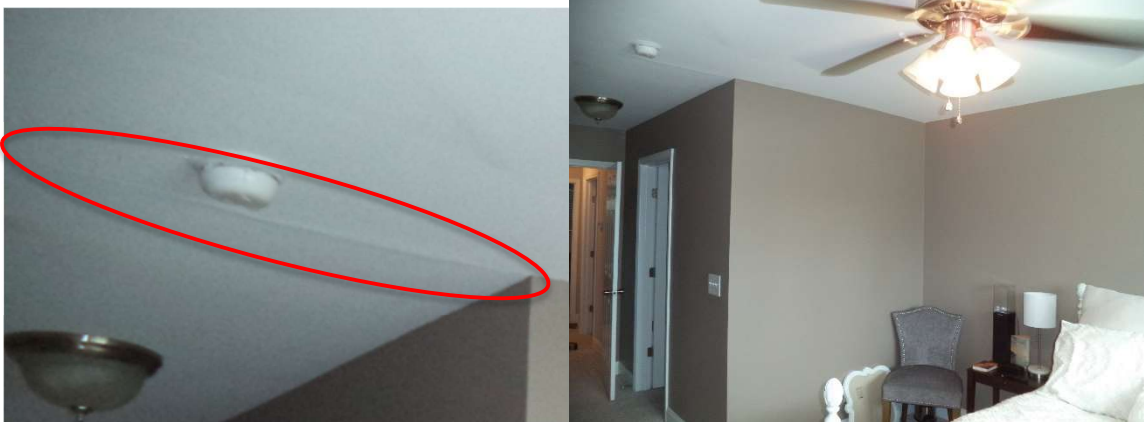
Ceilings throughout the house did not show indication of any active leaks. There was an observed joint cracking potentially due to normal thermal expansion of the home

Ceiling Joint in master bedroom shows some sign of cracking potentially from normal thermal expansion of the attic space | no active leak obvious in conjunction with joint | recommend minor maintenance and monitoring

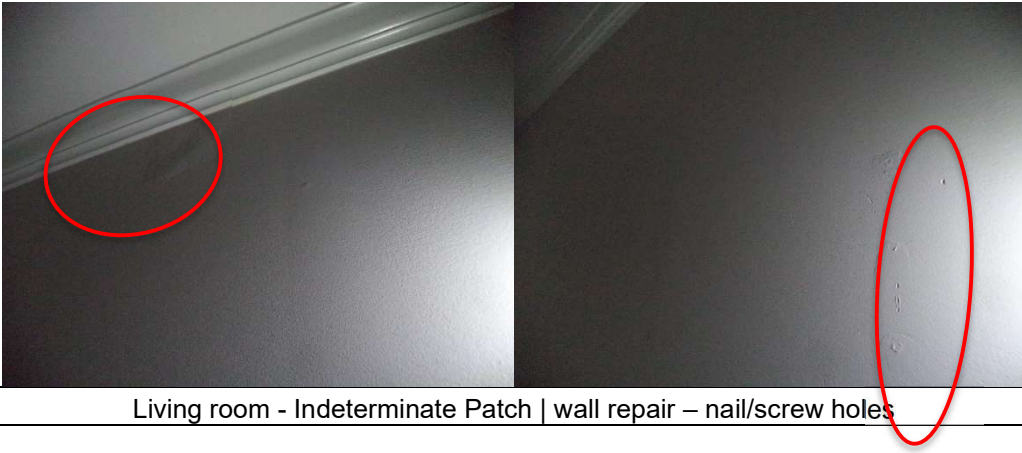
Living room - Indeterminate Patch | wall repair – nail/screw holes

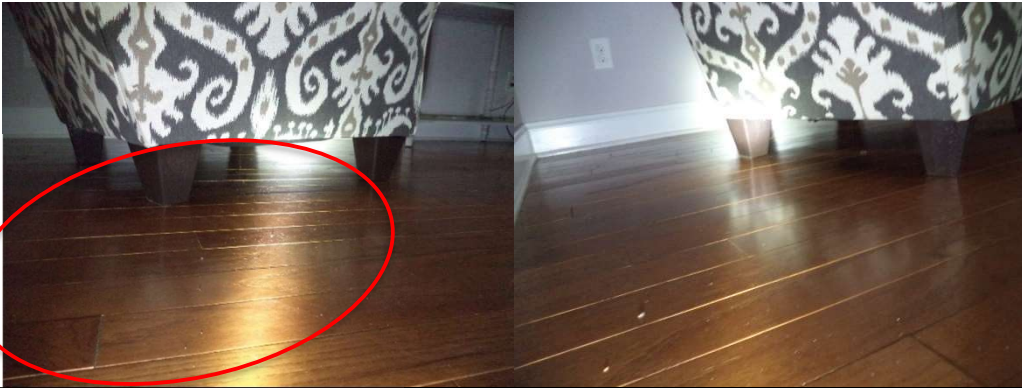
1st floor T-G wood flooring appears to have local low spots which may be due to installation techniques, but may also indicate moisture (spill, pet stains, or moisture wicking) | The flooring did not move or squeak | Recommend monitoring

Living Room Flooring presumed to be installed over vapor barrier on top of concrete slab

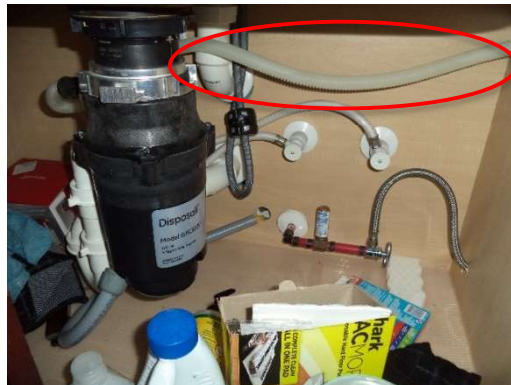
5.1 DISHWASHER

No Sanitary loop or air gap was noted | Recommend adding a loop under the sink to prevent backflow into dishwasher

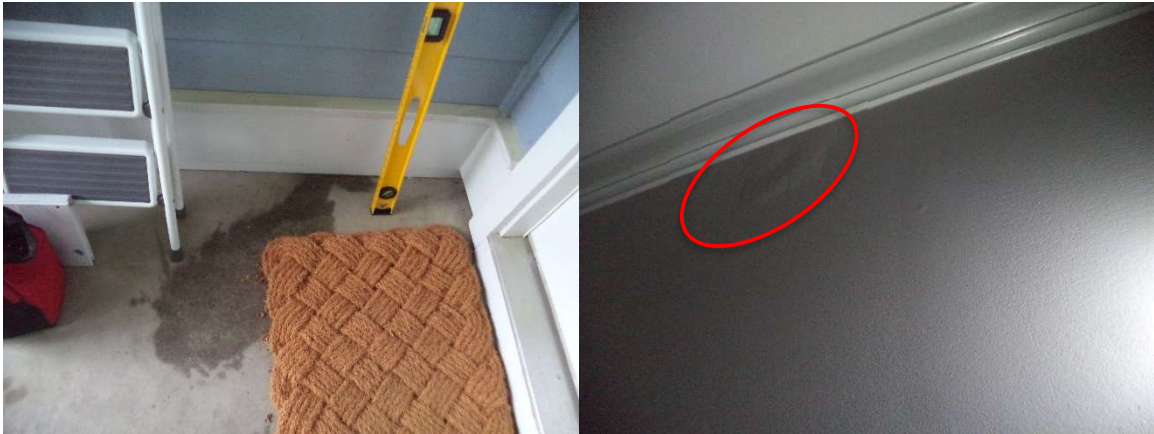
Potential past water issue in shared wall with East resident

Stain on Porch Concrete and Upper Drywall Repair

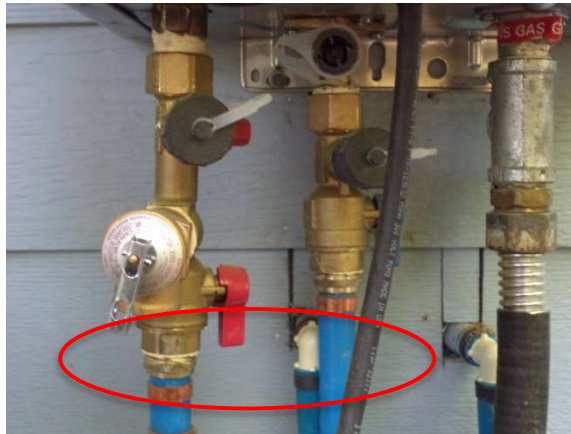
PEX tubing at the HW HTR – Insulation for exposed distribution piping is recommended to reduce freezing

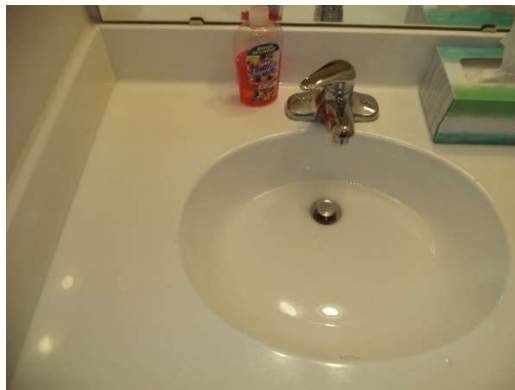
Master Bath – Sink was stopped and filled then drained. Drain was intermittent, but not clogged.

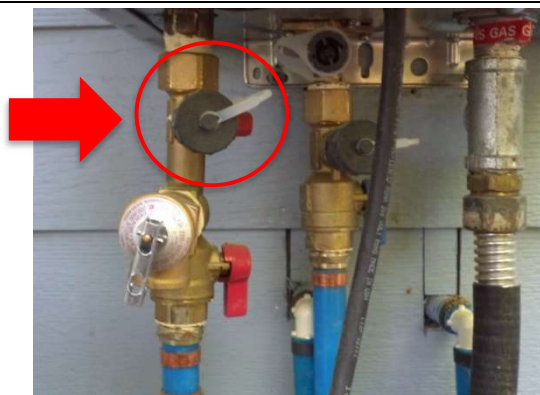
6.7 HOT WATER TEMPERATURE

Pre-set Temperature Valve – Could not confirm 120°F preset at tempering valve

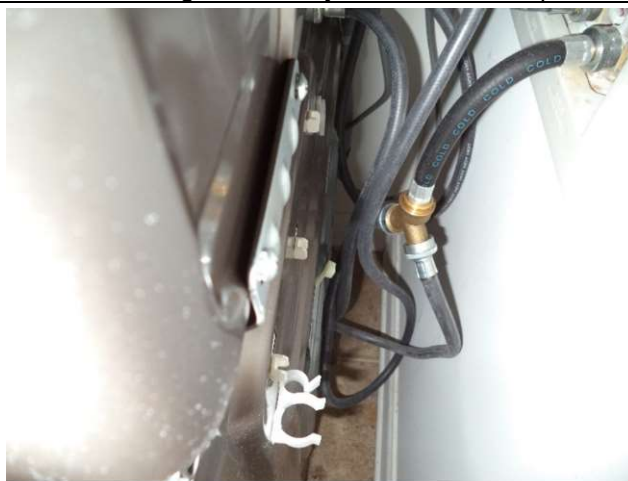
6.9 WASHER CONNECTIONS .

The existing washer connections were not visible behind the stacked washer/dryer unit, but were photographed by reaching to the rear of the machine. Recommend removing unit to check for any potential damage to hoses or fittings which are not evident in the below photo from the inspection. There is no evidence of water staining or leaking from the fittings, hoses or on the floor/wall to suggest the equipment is not functioning satisfactory at the time of inspection.

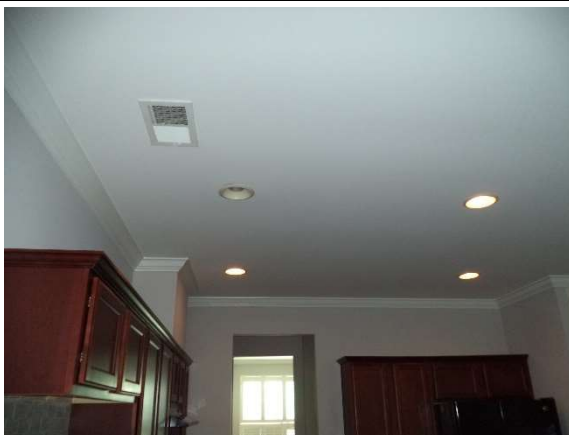
Recessed Lighting in the kitchen revealed one light was not functional (likely blown). Kitchen lighting appears to be lower wattage or on a dimmer switch. No Dimmer switch was located. This may be a wattage issue that should be addressed by changing to a higher watt bulb, or consulting a qualified electrician to modify the type of lighting available in the kitchen.

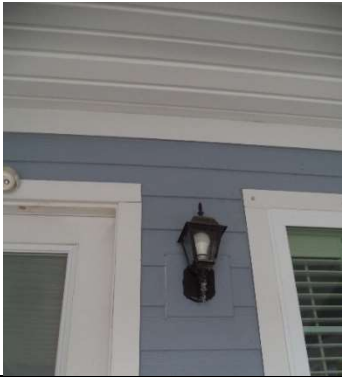
The lighting on the rear porch was tested from the wall switch bank adjacent to the rear entry and did not result in a functional porch light. Recommend replacing the light bulb and if results are unchanged consult a qualified electrician for troubleshooting or replacement of the fixture.

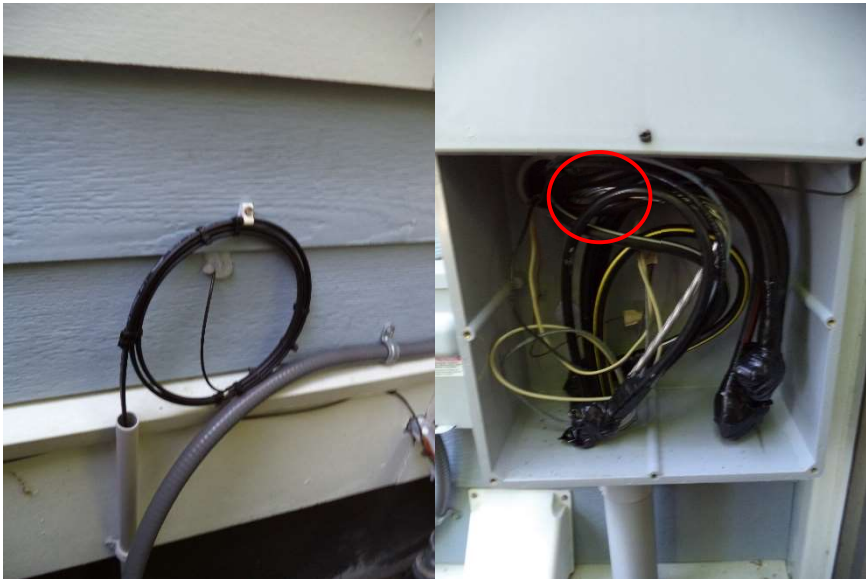
Ground wiring (unconfirmed) and Service Lateral wiring | A qualified electrician should confirm grounding location

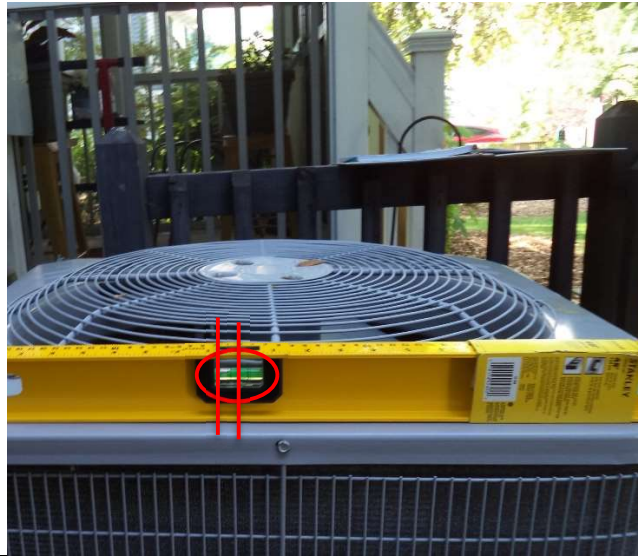
Exterior Condenser and Heat Pump are not level which may cause uneven distribution of internal oil and undue wear on the compressor

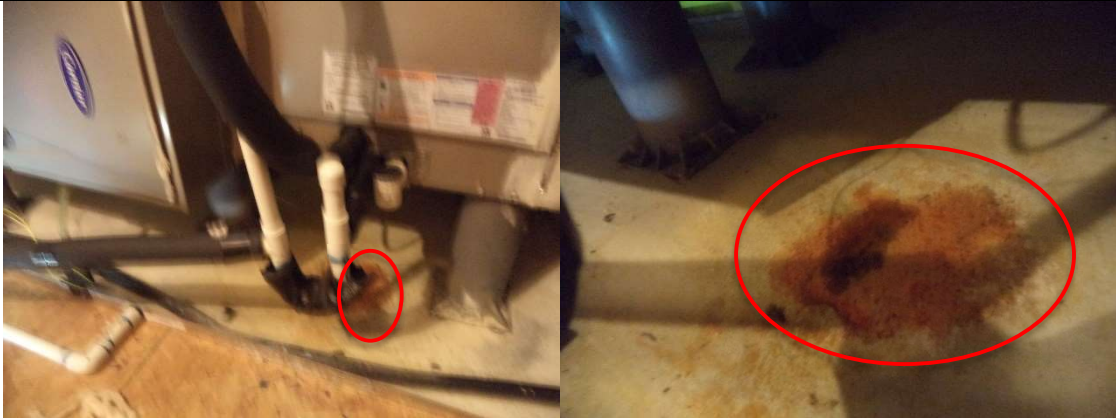
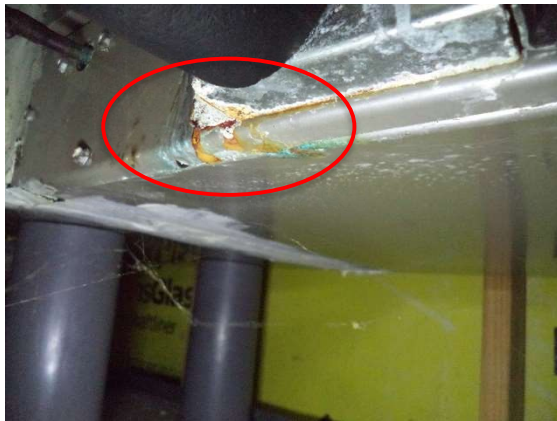
9.5 CONDENSATION LINE OR PUMP'S CONDITION / EMERGENCY DRIP PAN

Active Leak from condensate line connection with air handler cabinet | Recommend consulting a qualified HVAC technician to perform routine maintenance and evaluate the connection repair as needed.

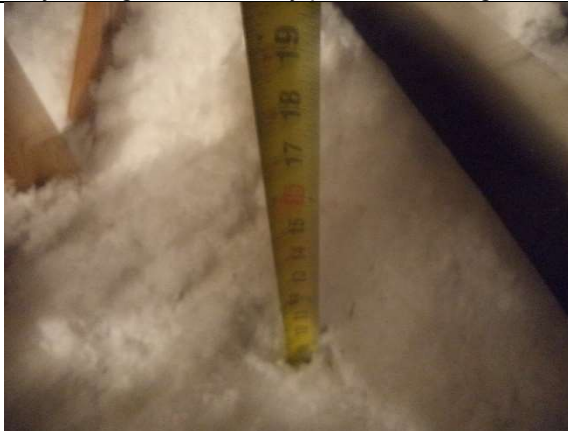
A recommendation to have an increase of insulation be installed in areas where the existing blown insulation has been disturbed and monitor any changes incurred by personal storage in the attic.

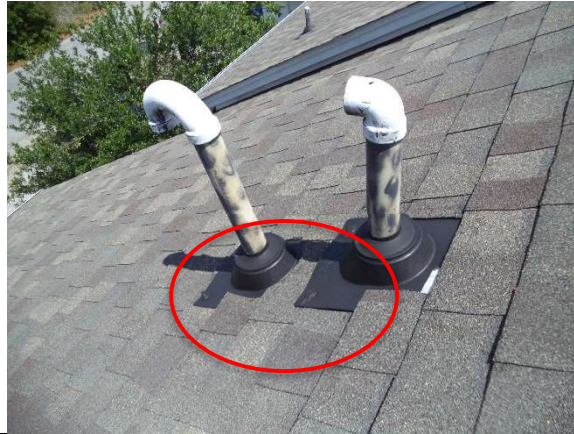
Comments**1.2 ROOF PENETRATIONS**

Roof Penetration boots did not have consistent shingle coverage as others viewed and may require some caulk to prevent wicking or leaking. Monitor from attic over time or consult with a qualified roofing professional.

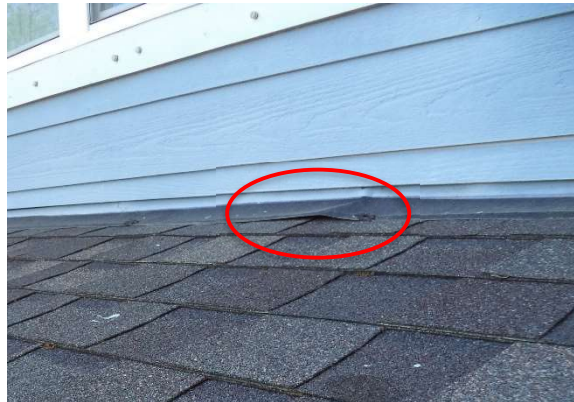
**1.4 ROOF FLASHING**

Flashing crimp at porch-wall attachment below window should be caulked to prevent moisture from wicking below siding or posing a potential leak with driven precipitation.

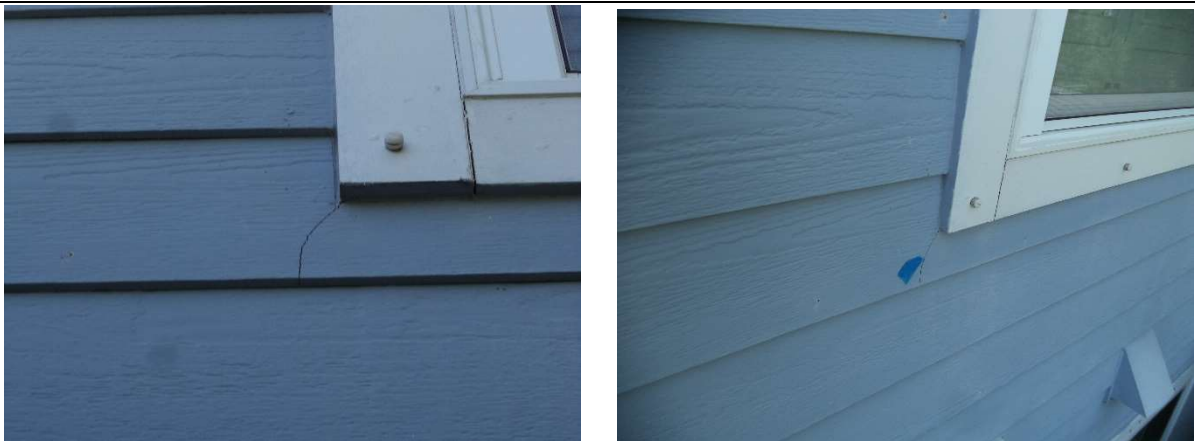
Rear corner of upper bedroom window adjacent to porch roof

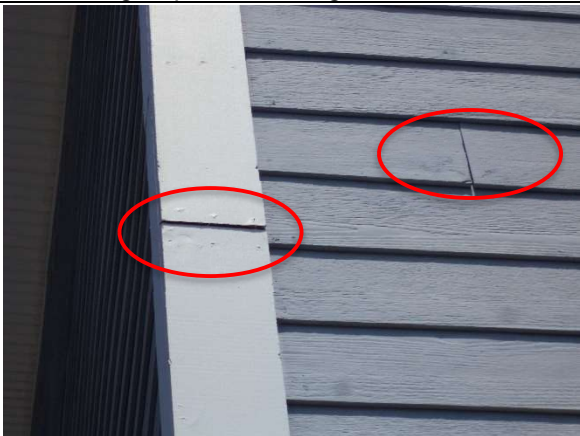
Siding and Facia/Trim locations where siding requires caulking maintenance.

Front Upper Corner over Porch

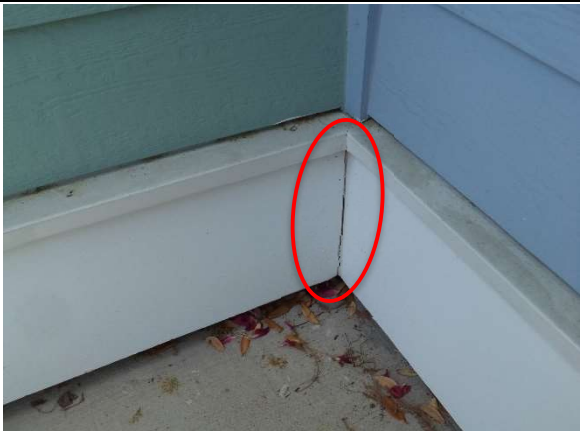
Front Porch – Corner baseboard

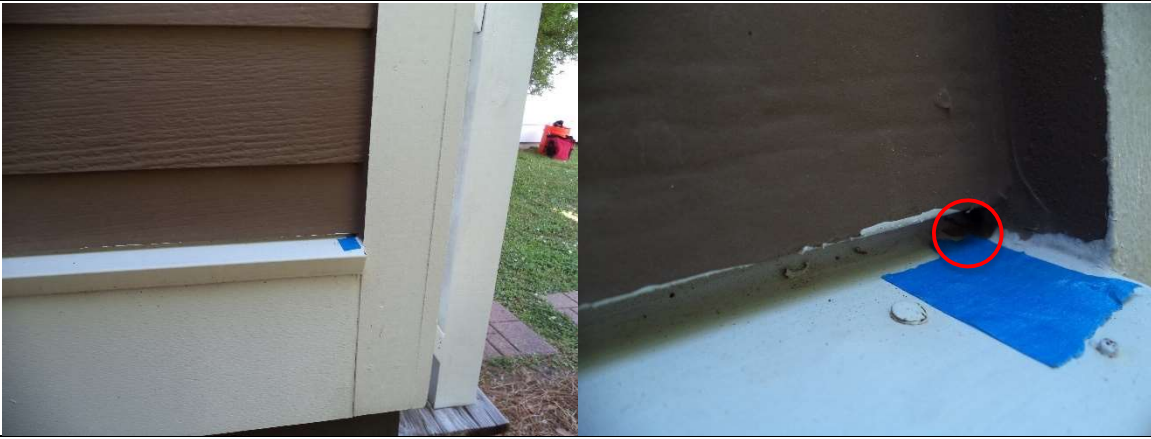
Rear Porch – Small hole for insects to penetrate to wood

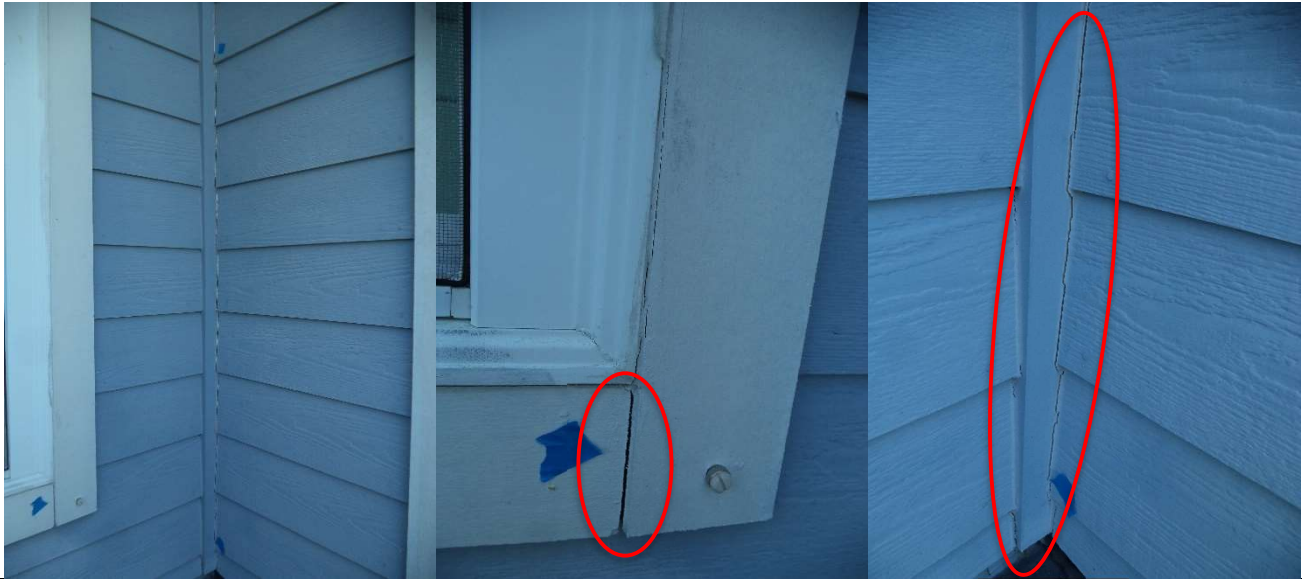
Rear 2nd Floor Siding above porch | Window casing | Corner Siding

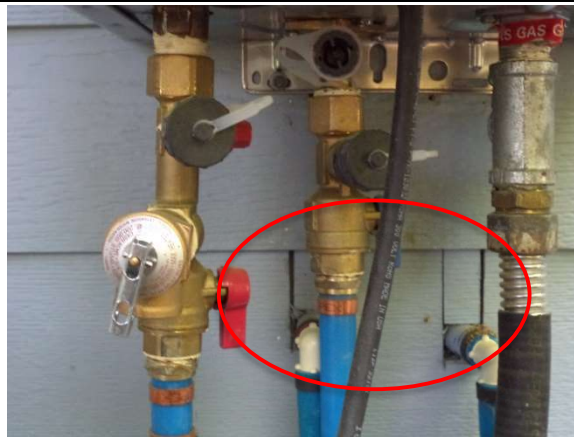
Rear – Instantaneous HW penetrations in siding

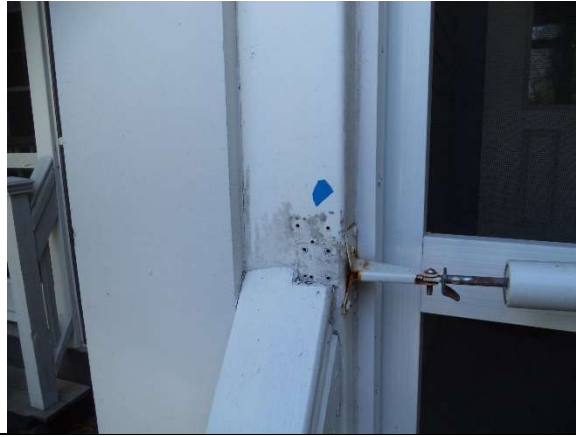
Rear – Porch Screen Door hydraulic cleat attachment holes

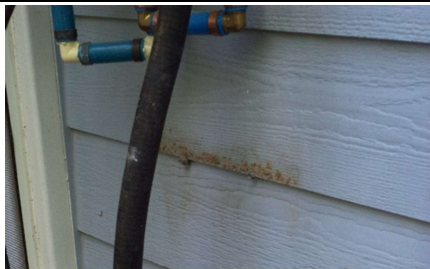
Rear

There is rust on the siding below the Rinnai HW HTR which is not an active leak, but appears to be where a bracket or equipment was removed.

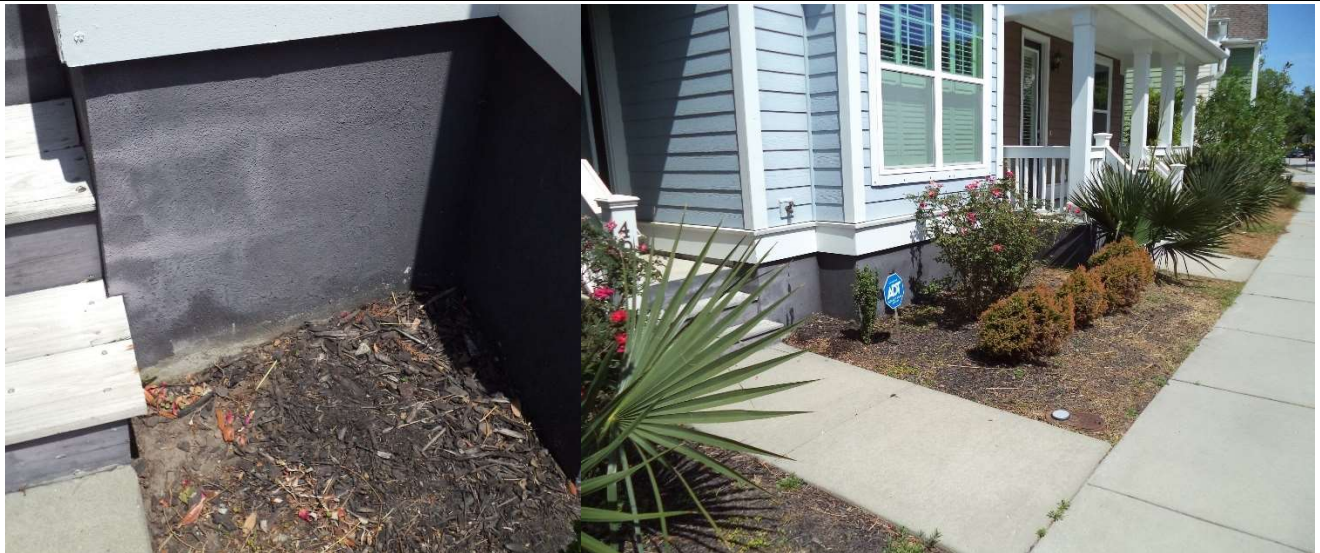
Front

Block wall appears to be in satisfactory condition but recommend resealing to protect and prevent moisture intrusion.

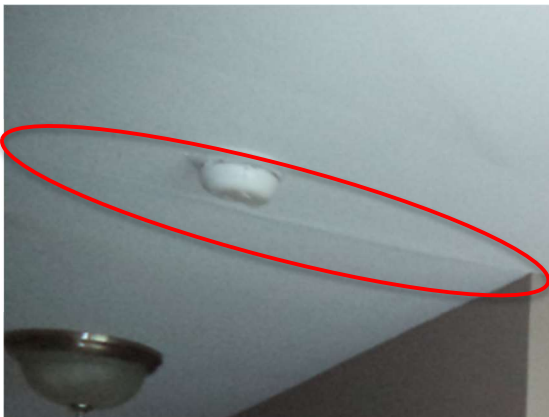
Ceilings throughout the house did not show indication of any active leaks. There was an observed joint cracking potentially due to normal thermal expansion of the home

Ceiling Joint in master bedroom shows some sign of cracking potentially from normal thermal expansion of the attic space | no active leak obvious in conjunction with joint | recommend minor maintenance and monitoring

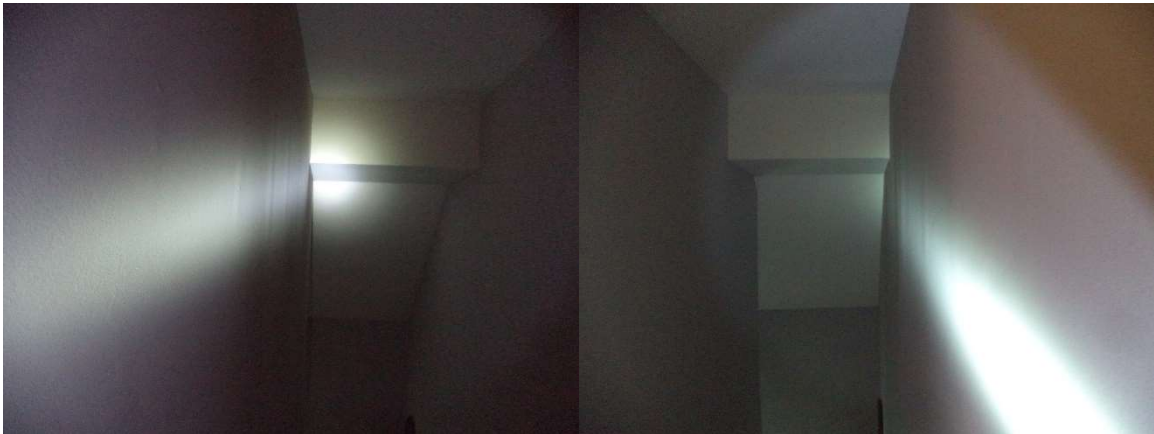
Stairwell - Light wash from flashlight revealed typical tape lines with normal wall construction (Typical)

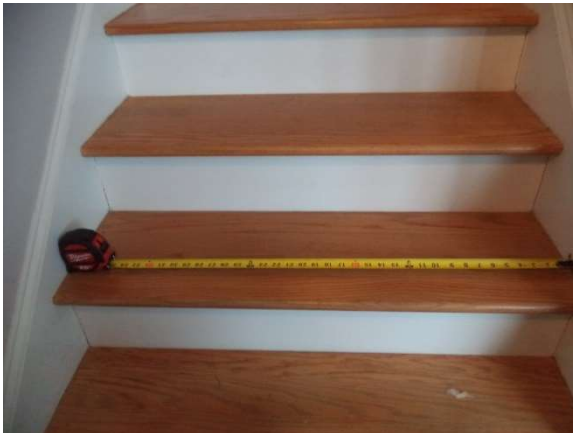
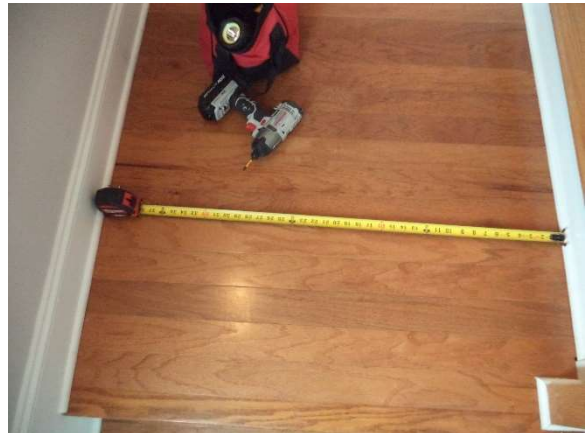
Stairs are compliant for residential construction

Stairway width shall be a minimum of 36" | Shown is ~ 40" for landing and stair

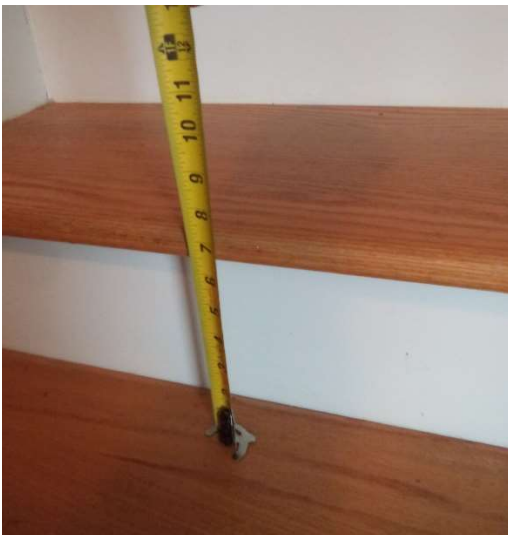
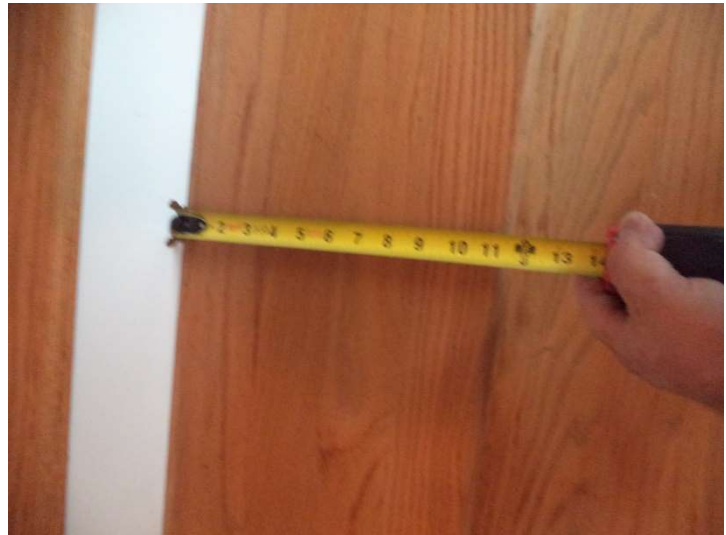
Stair tread shall be no less than 10" run and 7 $\frac{3}{4}$ " Rise" | Shown are 11" run and 6 $\frac{3}{4}$ " rise

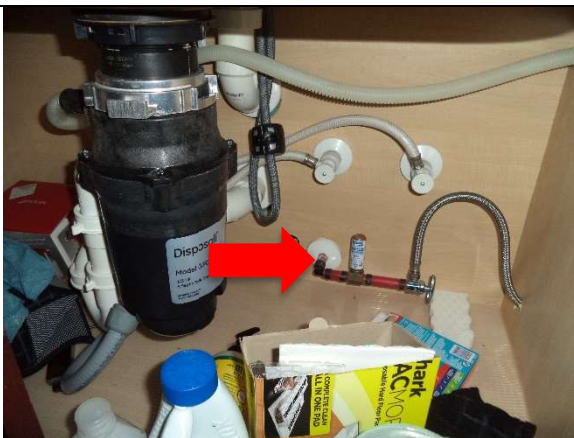
No Sanitary loop or air gap was noted | Recommend adding a loop under the sink to prevent backflow into dishwasher

Dishwasher supply – 1/2" PEX to SS Braid Hose

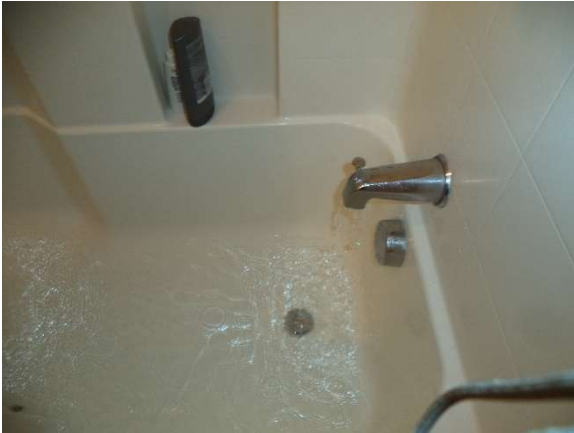
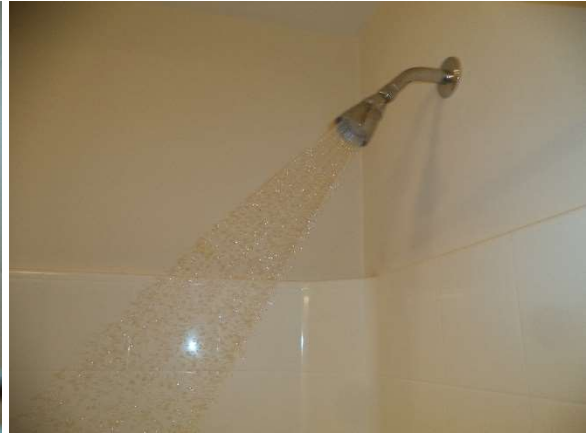
Bath 1 Tub/Shower

Diverter valve has a small leak when shower is activated | Temp from cold to warm was less than 30 seconds and hot within a minute | Tub drain held water without any obvious draining over several minutes | Drain was free flowing | Water flow was slightly diminished when flushing toilet.

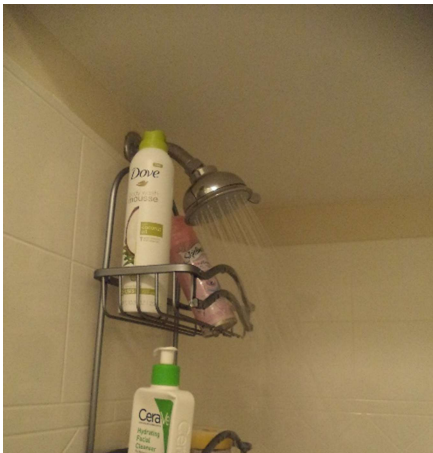
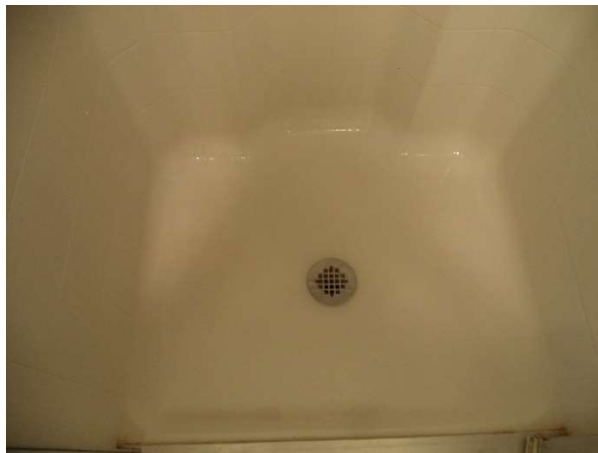
Bath 2 Shower

Temp from cold to warm was less than 30 seconds and hot within a minute | Shower has a door which freely opens/closes outward | Shower drain was free flowing | Water flow was slightly diminished when flushing toilet

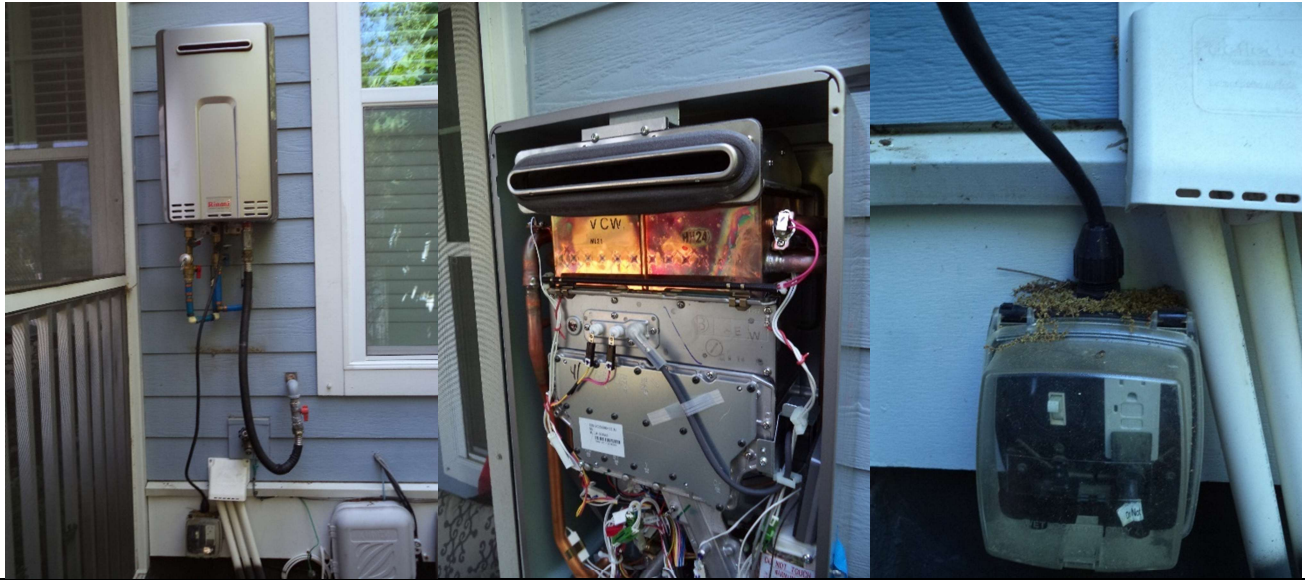
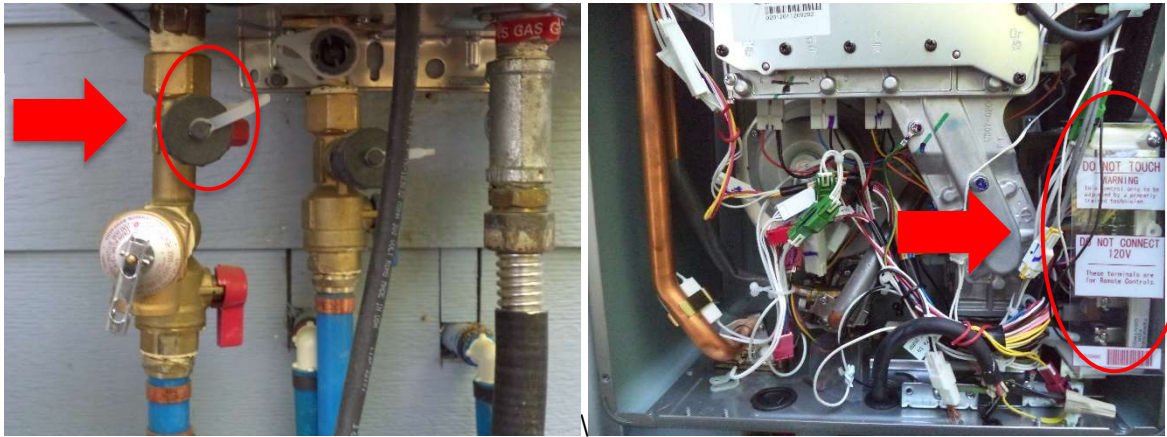
The instant hot water heater does not have a thermal expansion tank which isn't required by the International Plumbing Code. The tempering valve is the one with the red "button" and is factory set to 120°F, but could not be confirmed visually. The thermal/pressure relief valve is integrated into the hot water side tempering valve fitting. The TPV was not tested, but appeared to be in satisfactory condition with no corrosion evident or leaks noted at the time of observation. This is a gas fired unit which does require ignition, which should be automatically determined internally and is the reason for hardwired outlet below the unit. The plug head in the outlet could not be resolved for termination and purpose.

Rinnai Instant HW HTR tempering valve is set to 120°F for MFR instructions; temperature could not be confirmed for max setting, but no visible tampering was evident to suggest the valve has been altered. There are not owner operational controls internal to the unit. There are explicit warning for trained technicians to be contacted to alter any internal setting and setpoints.

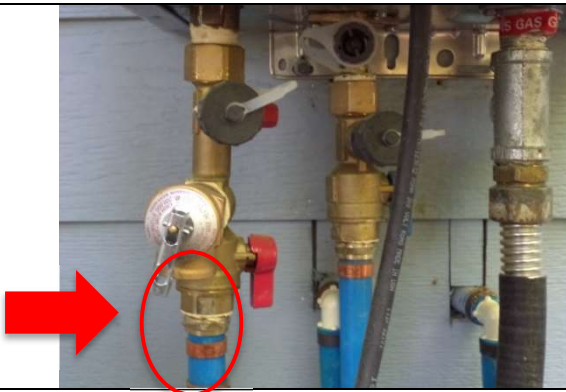
6.8 T&P VALVE EXTENDED TO WITHIN 6 INCHES OF FLOOR OR TO OUTSIDE

Existing piping for the T&P valve on water heater fails to extend to grade to prevent potential injury or damage. Recommend installing appropriate threaded fitting and piping (CPVC, COPPER, G.STL) with open end terminating 6" above grade to prevent injury or damage.

Install relief pipe to grade to prevent injury or damage

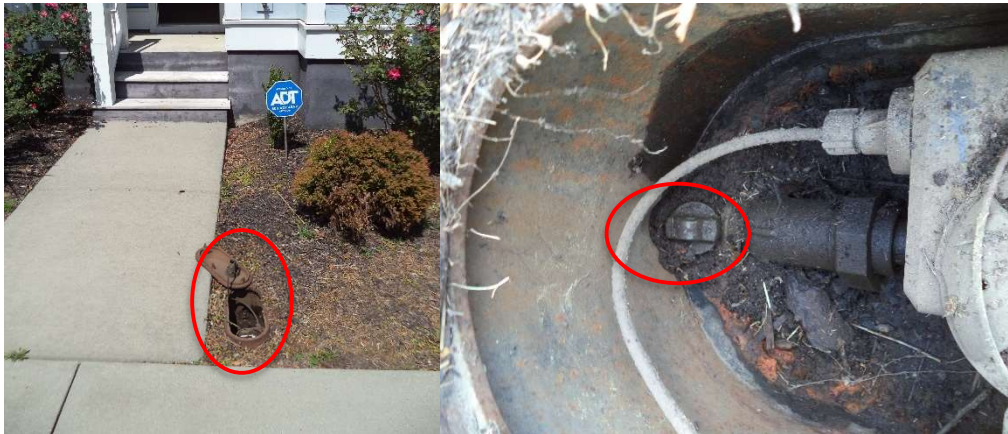
**6.11 MAIN WATER SHUT-OFF VALVE (Describe location)**

The main water shut off is at the outside meter near the road.(Water key required) You can purchase a water key for use in an emergency at most hardware stores. A secondary shut off would be at the Rinnai Instant HW HTR that does not require a water key. I recommend you operate these locations independently and become familiar to ensure operating properly in case of an emergency.
