General Summary

Client Name: Justin A Smith Property Address: 1234 The Town Circle
(Street)

Client Name: Jane B Smith N. Charleston, SC, 29405
(City, State, Zip Code)

Inspector Name: Justin Oliver LIC#: 49689

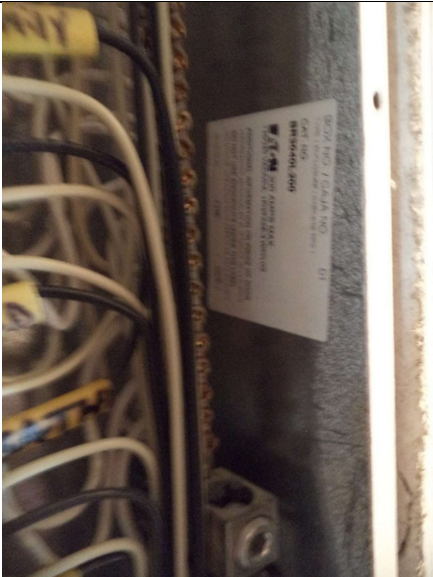
1/0 AWG CU Service Wiring

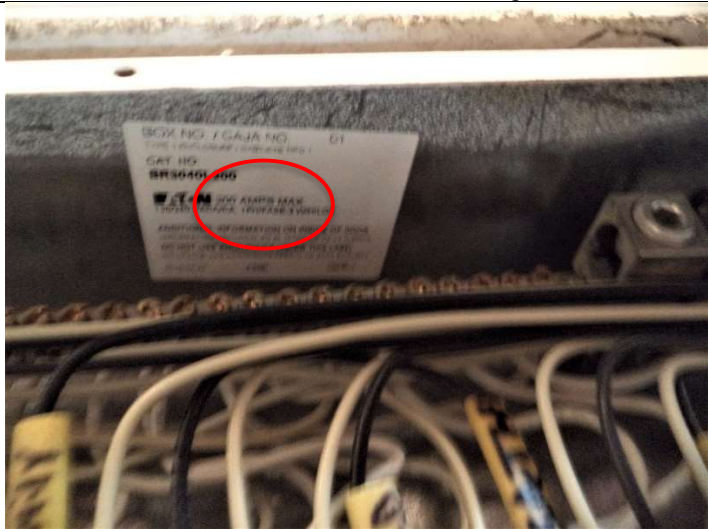
Branch Wiring is 10/12/14 AWG

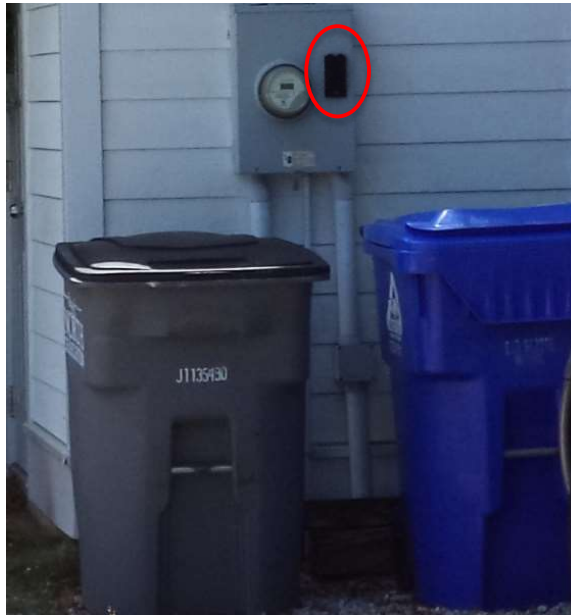
The main electrical disconnect for the home is located at the meter box.

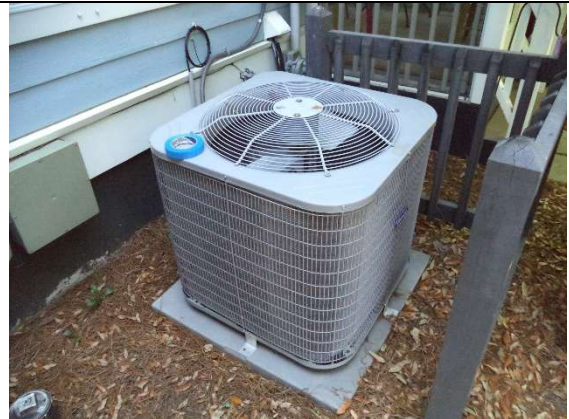
Rear - Condenser coil and

Exterior Condenser and Heat Pump are not level which may cause uneven distribution of internal oil and undue wear on the compressor

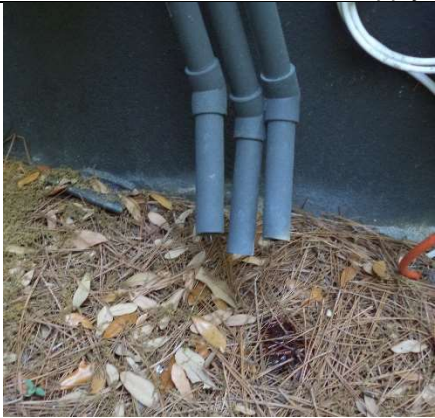
Rear – Active Condensate Line and Secondary

The air handler has a primary condensate drain which was confirmed to be flowing outside. There was not any level of water present but moisture had accumulated and is leaving a rust stain in the drip pan. The condensate line connection to the air handler cabinet shows some sign of calcification and rust forming at the discharge fitting. There was no moisture observed on the wooden maintenance deck at the time of observation.

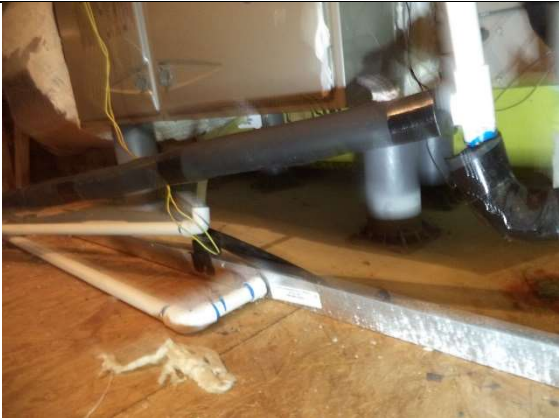
Condensate Line | Secondary Line | Drip Pan

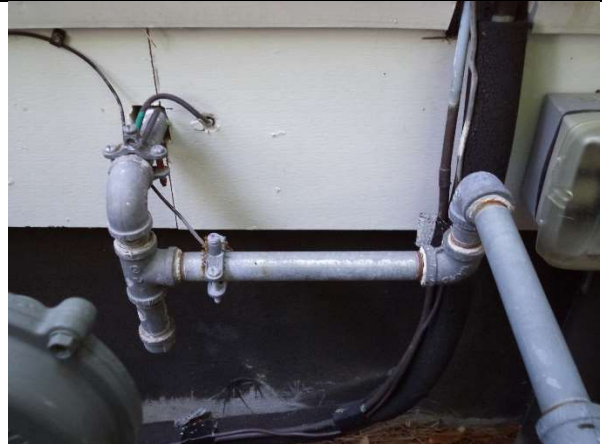
Rear - Bonded Gas Supply Entry to Home

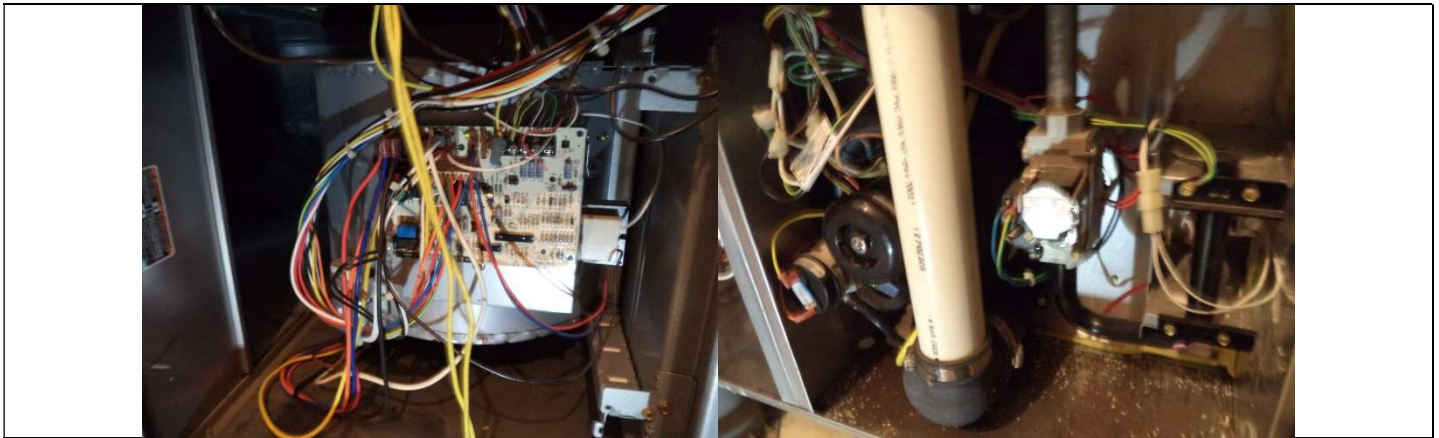
Interior of the Furnace

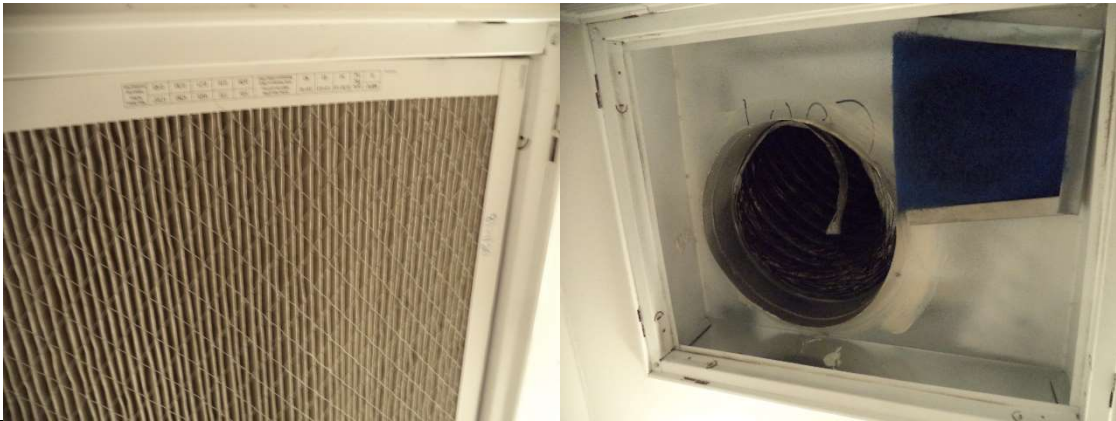
2nd Floor Air Return

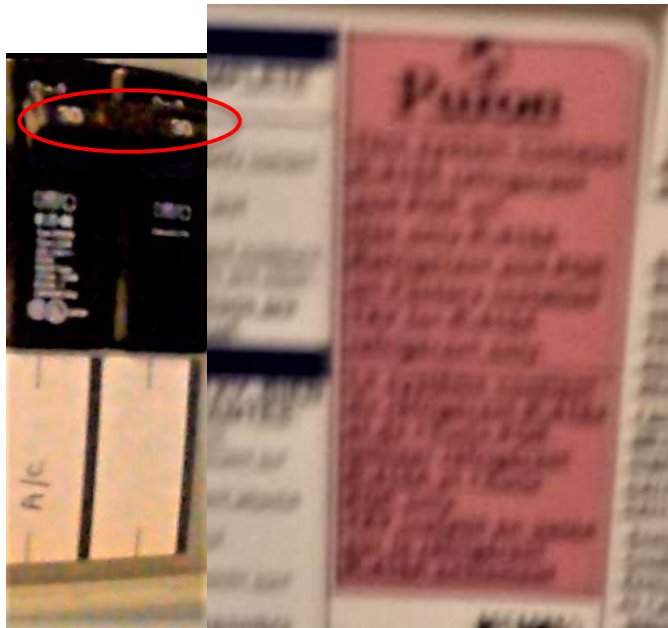
External A/C Condenser Unit Data Plate

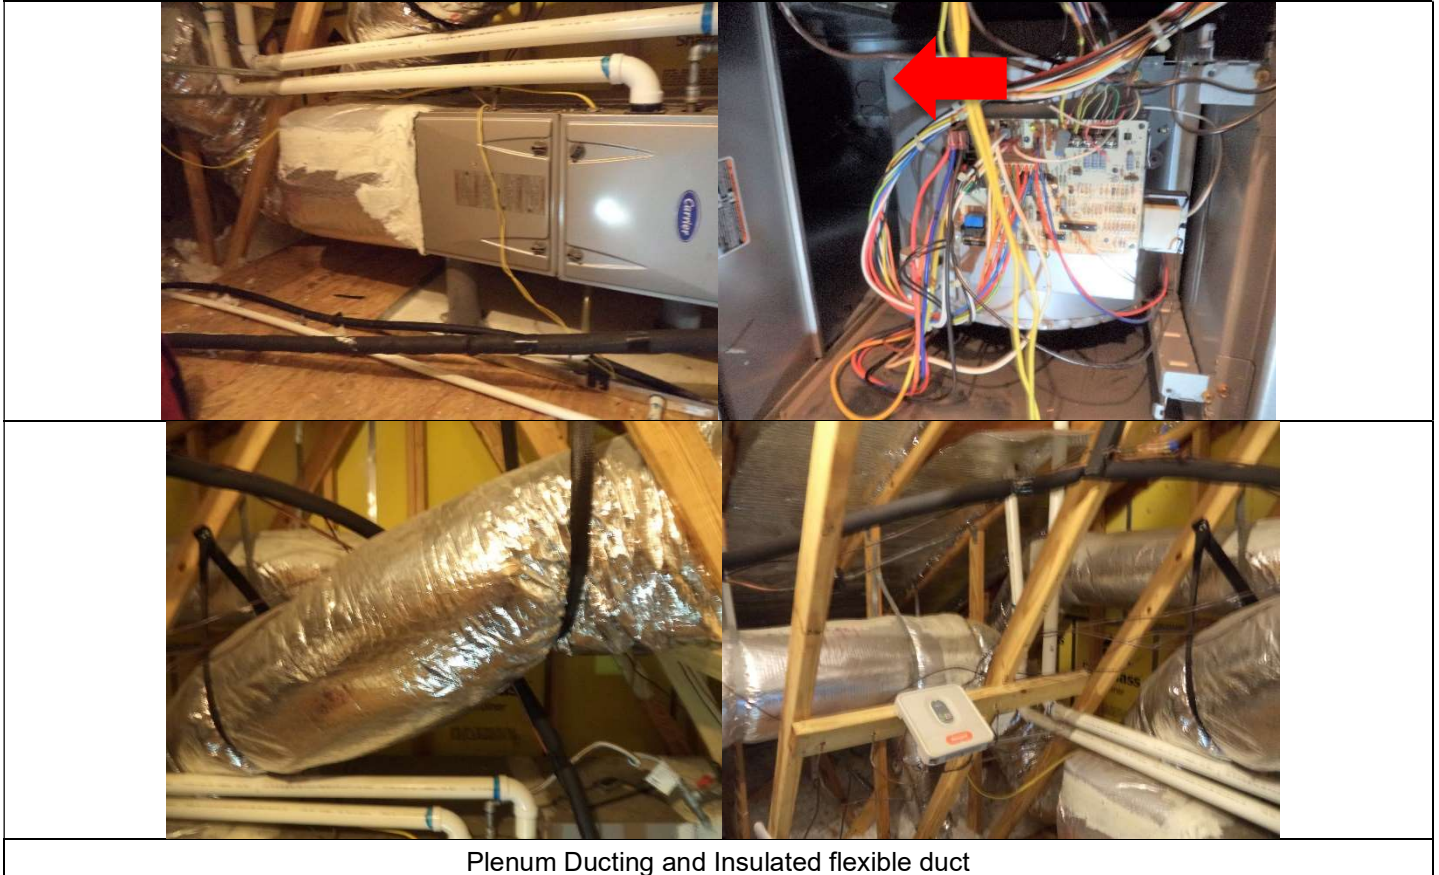
The house distributions system consists of two returns and zoned ducting air handler on each level. The ducting is insulated flexible ducting which appears to be supported evenly with plastic strapping throughout the semi conditioned attic space. There were no crimps or major restrictions that were observed in the ducted attic space at the time of inspection. Ducting to the 1st floor was not visible and therefore not observed. The insulation on the ducting appeared to be in satisfactory condition at the time of observation. The plenum appears to be constructed of insulated rigid duct by observation in the air-handler compartment. The duct and plenum are sealed at the joints with HVAC mastic. There was a noticeable leak from the intake plenum sheet metal seams where mastic was not present. This can be sealed by using a UL 181A or 181B adhesives or tape.

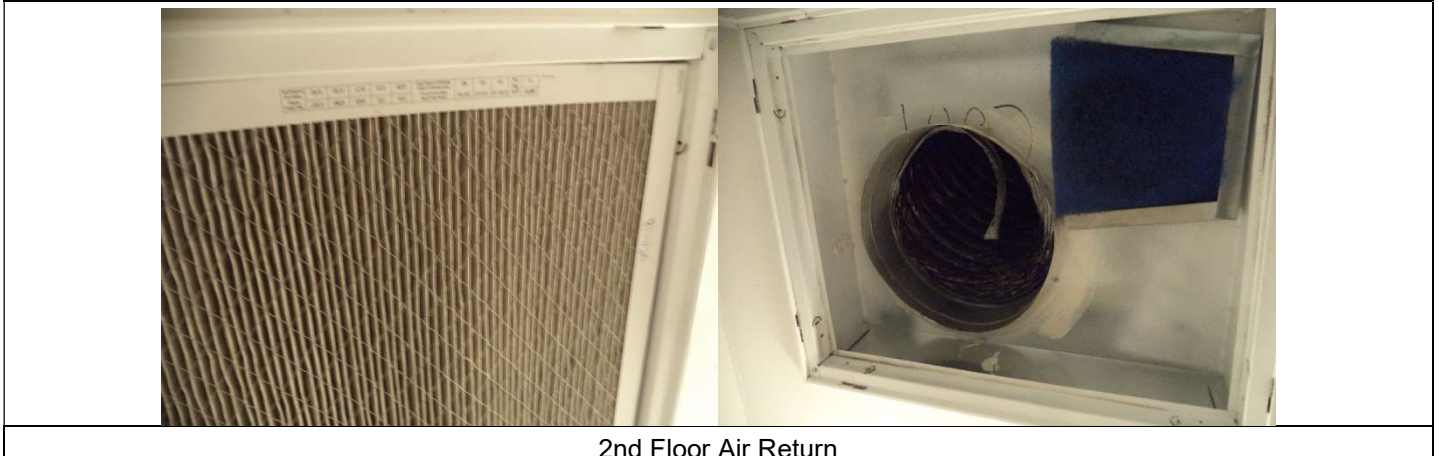
Filters for the returns were installed. The registers will require routine monthly inspection and filter changes for the system to function as intended. Dirty filters will make the system less efficient, but can also accelerate wear and damage the system due to over working the heating and cooling components.

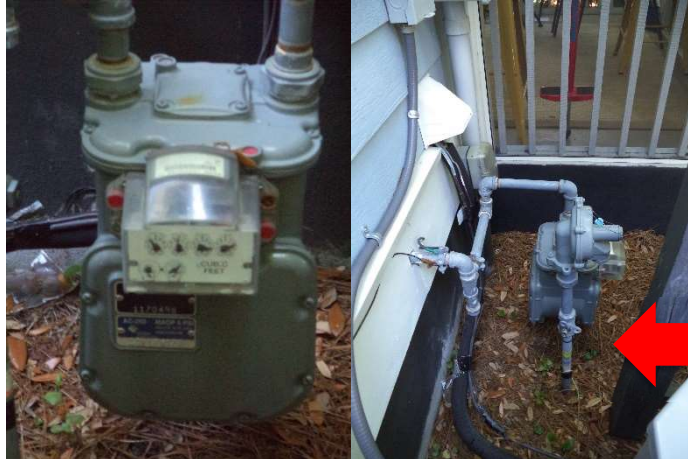
Gas Meter and Shutoff valve

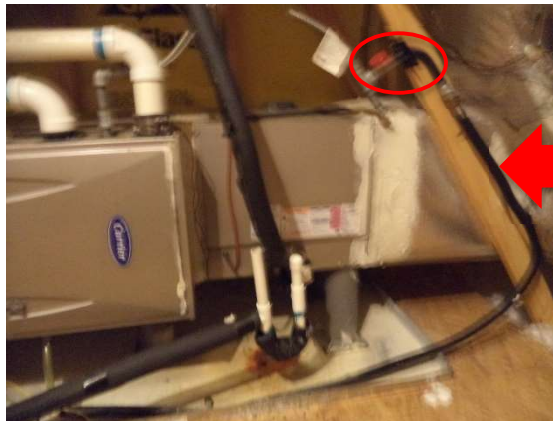
Furnace Shutoff Valve circled | CSST Hose indicated by arrow | Care should be taken when placing any personal items in the attic to prevent damage to the gas supply

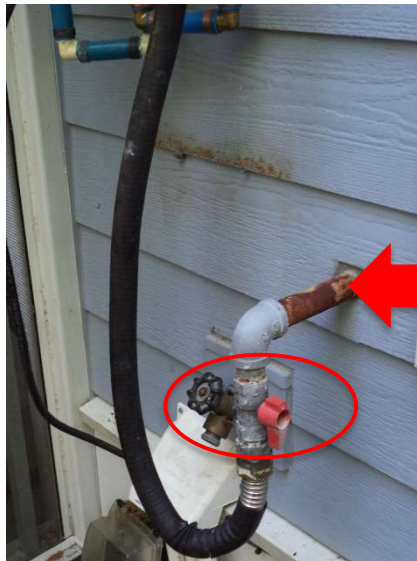
Rinnai HW HTR Shutoff Valve circled | Galv. Steel supply should be coated to prevent potential for leaks at threading or pinholes

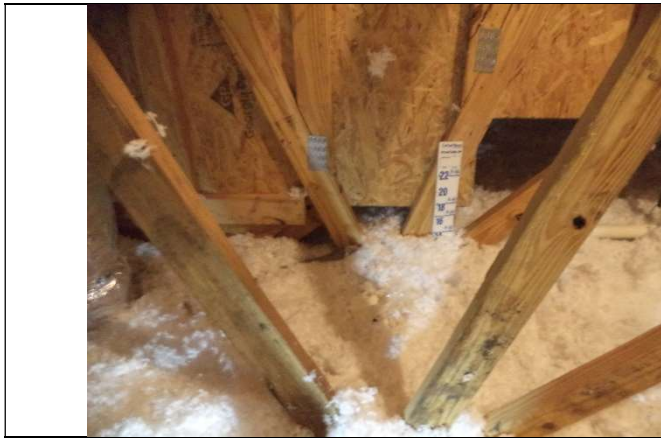
Facing West - attic view

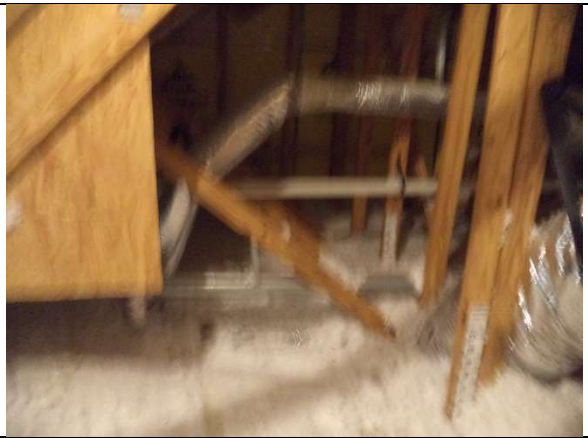
Facing West - Attic view over kitchen

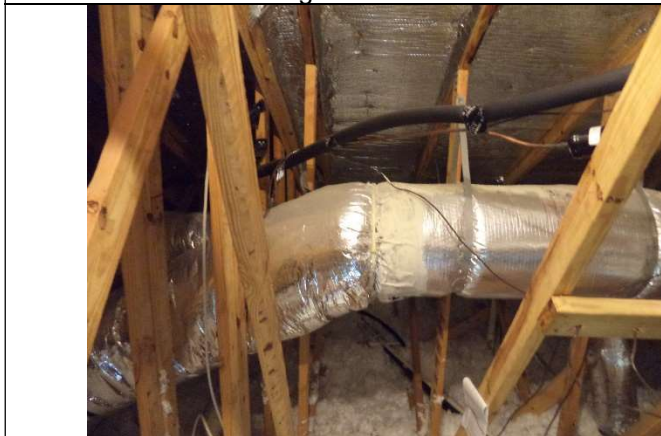
Facing North - Attic view over bedrooms

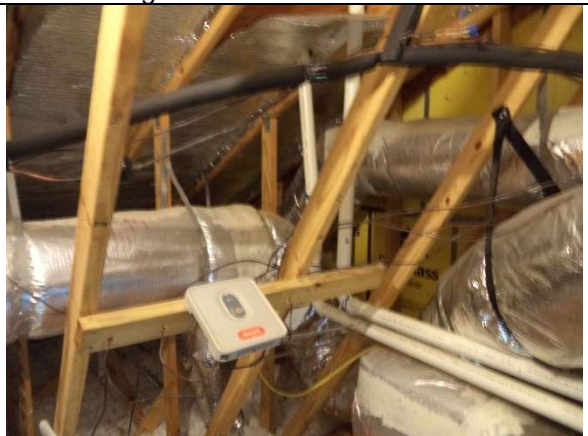
Facing North - Attic view ducting plenum and ducting
